Sample Building Report

Inspect Detect Consultants

Complies with Australian Standard AS 4349.1-2007 Inspection of Buildings Part 1: Pre Purchase Inspections – Residential Buildings – Appendix “C”

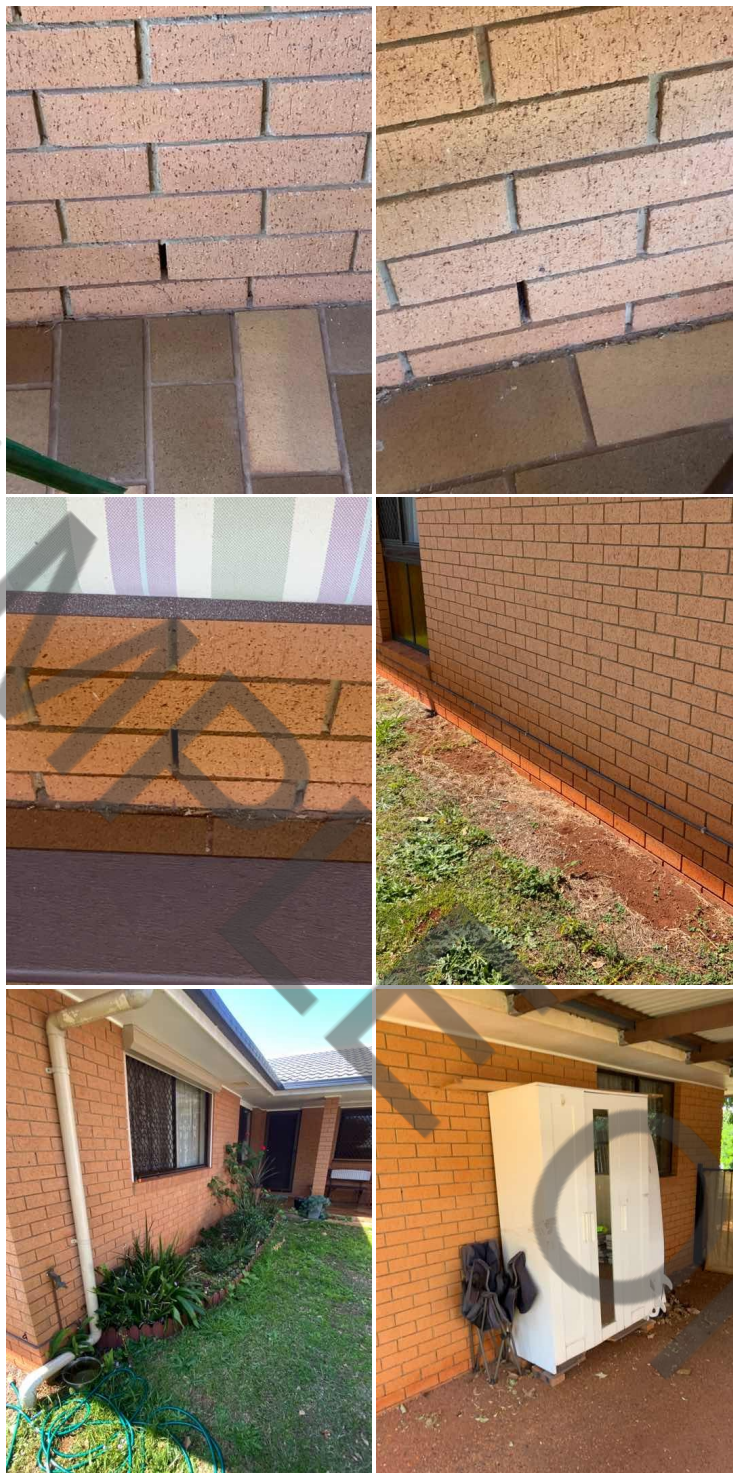
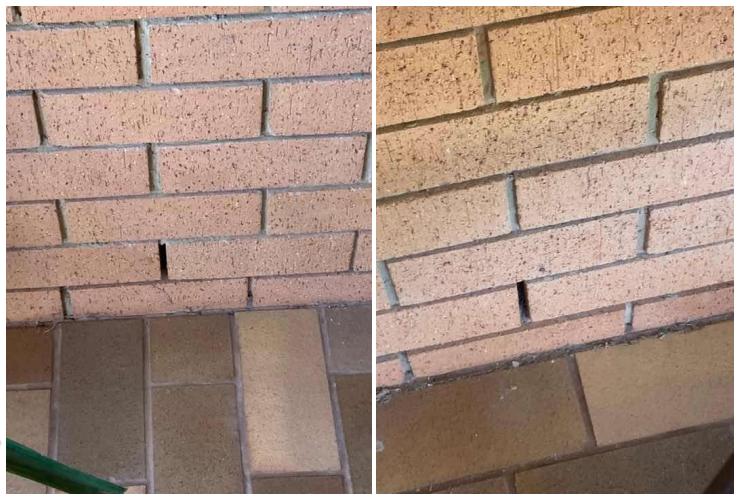
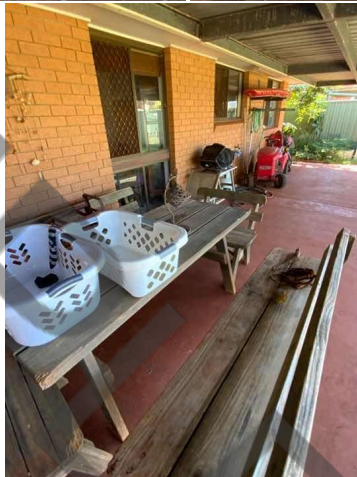
Weep holes do not have min. clearance of 75 mm
 No Expansion/Control Joints
 Stored items against wall restricted inspection
 Different/Discolouration of bricks
 Further investigation recommended
 Maintenance required

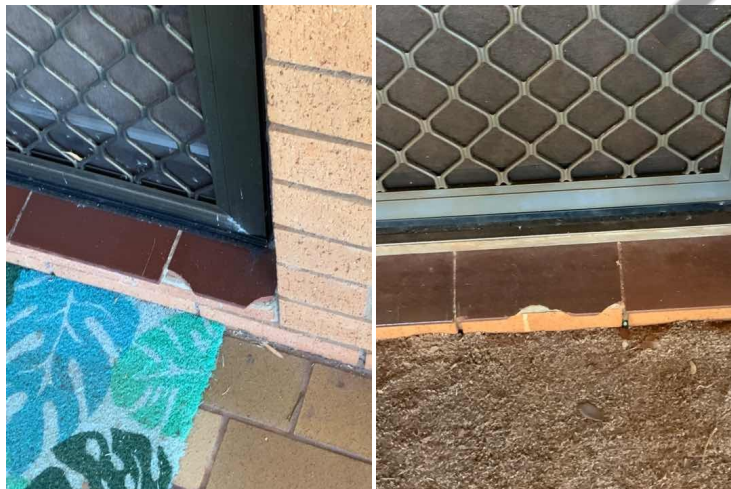
Cracked/broken tiles to sill
Repairs recommended

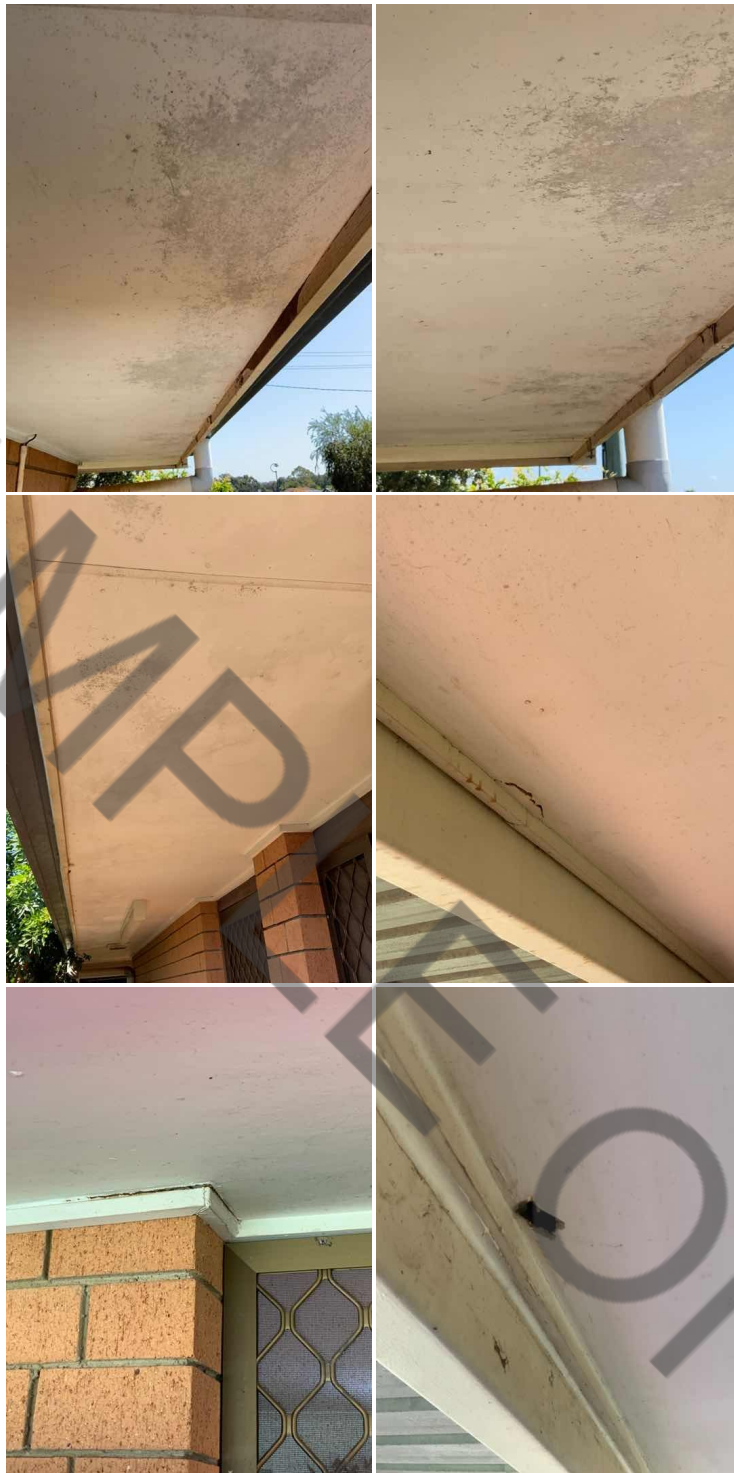
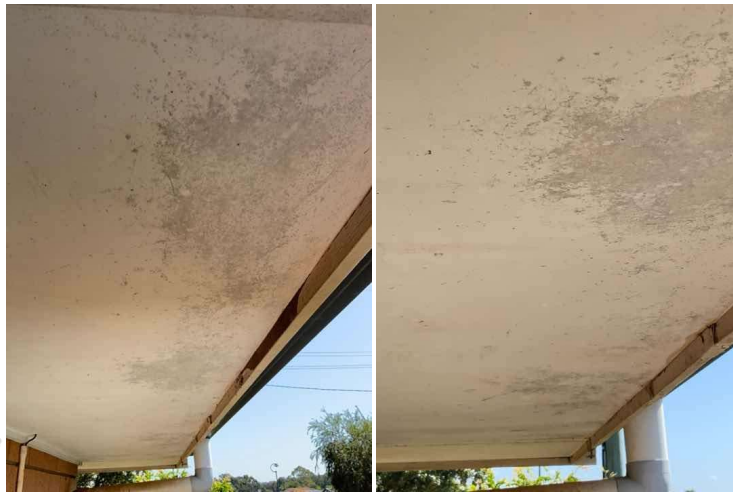
Minor cracking to eave sheet
Hole in eaves sheeting
Mould to eaves sheeting
Water staining
Further investigation recommended
Maintenance required

F C sheeting prior to 1990 may contain asbestos therefore an asbestos audit is recommended. Any repairs or maintenance of asbestos products should only be undertaken by professionals trained in handling of asbestos. Asbestos products should be kept painted and sealed to eliminate air borne fibres. If deflection is noted, we recommend invasive inspection to determine reason for deflection. Consult builder to determine cause and cost of repairs if required before you make your purchase.

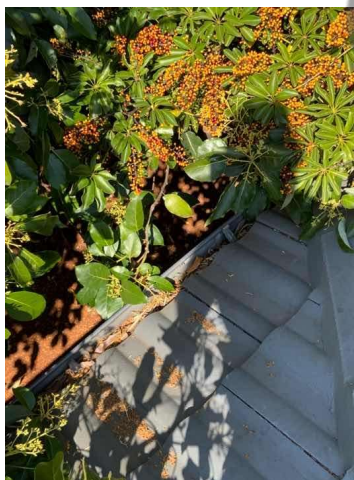
General deterioration of gutters
Debris in gutters-cleaning recommended

Due to breakdown of organic matter that can build up in gutters, acetic acids are produced which can accelerate corrosion. It is suggested that the gutters be cleaned out annually to minimize the potential blocking of the downpipes and the acceleration of corrosion in the gutters. When box gutters are noted with no access further investigation is required. Consult plumber for costing of repairs before making purchase.

Debris in guttering areas- this requires cleaning out to prevent blocking of down pipes and leaking into eaves and fascia. Recommendations: Have gutters cleaned and assessed by a plumber for adequate fall. Also regularly clean to prevent ponding. Ponding water will contribute to rust.

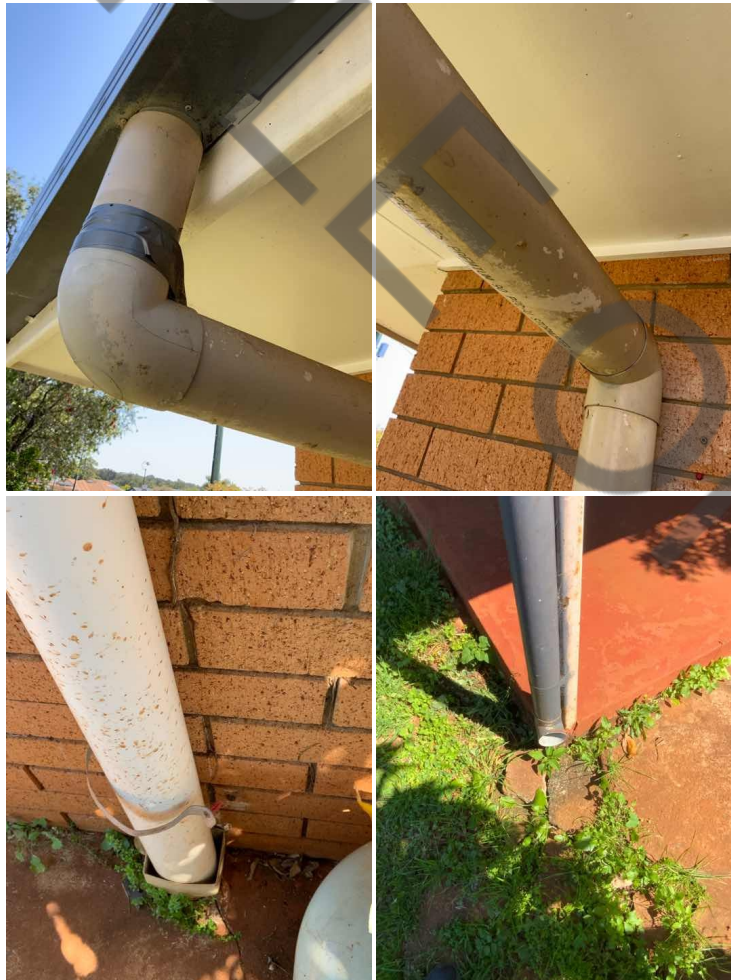
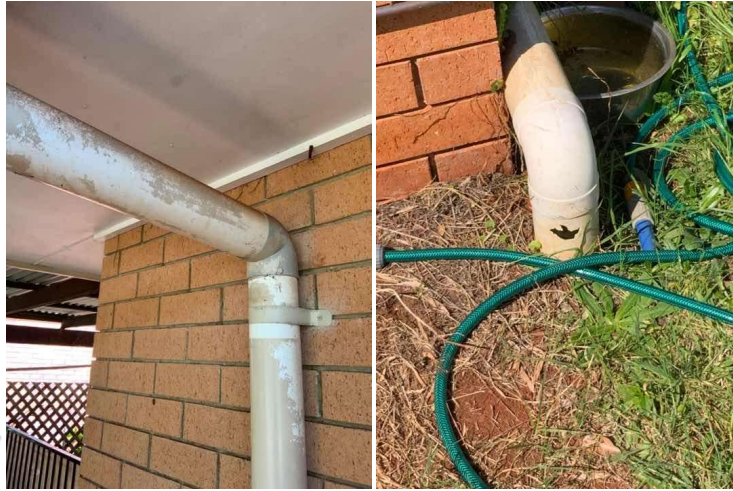
Downpipes not connected to stormwater
 Damage to downpipe at junction to stormwater
 Paint stress to downpipe
 Loose downpipe bracket
 Patch repairs downpipe
 Maintenance required

It is recommended that all downpipes be connected to a stormwater system to minimize the potential of localised flooding. High moisture levels can affect the foundations and also encourage termite infestations. Drainage inspection is not carried out under a visual Building inspection only visual defects will be noted, Downpipes are required to have a 25 mm gap from dwelling for visual zone to detect any possible termite activity behind pipe near the ground access area. Consult plumber for costing of repairs and further advice before you make your purchase

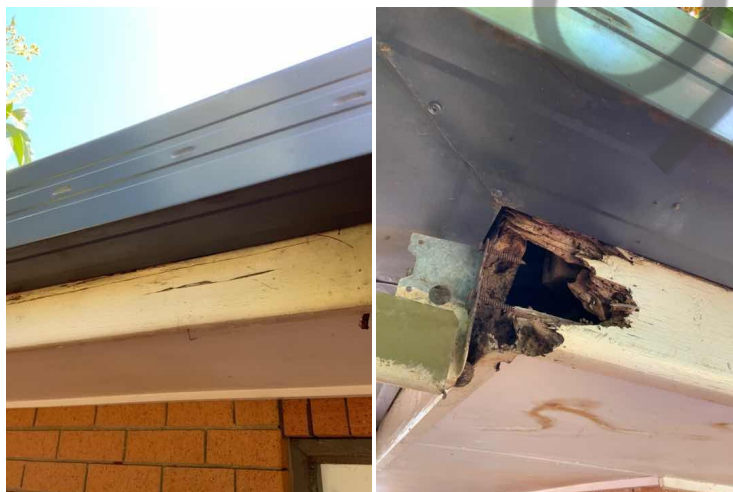
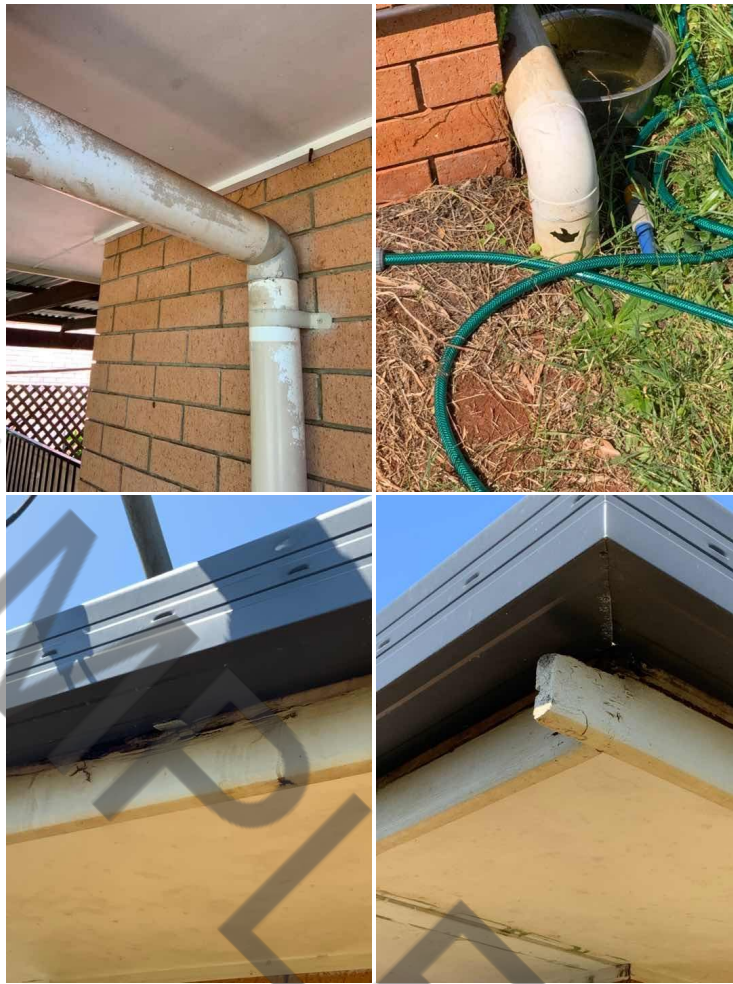
Rot to Fascia
 Splitting to timber fascia
 Minor paint stress
 Further investigation recommended
 Repairs required

Timber fascia that is noted with rot requires further investigation by a builder to determine the cause and cost of repairs, before you make your purchase.

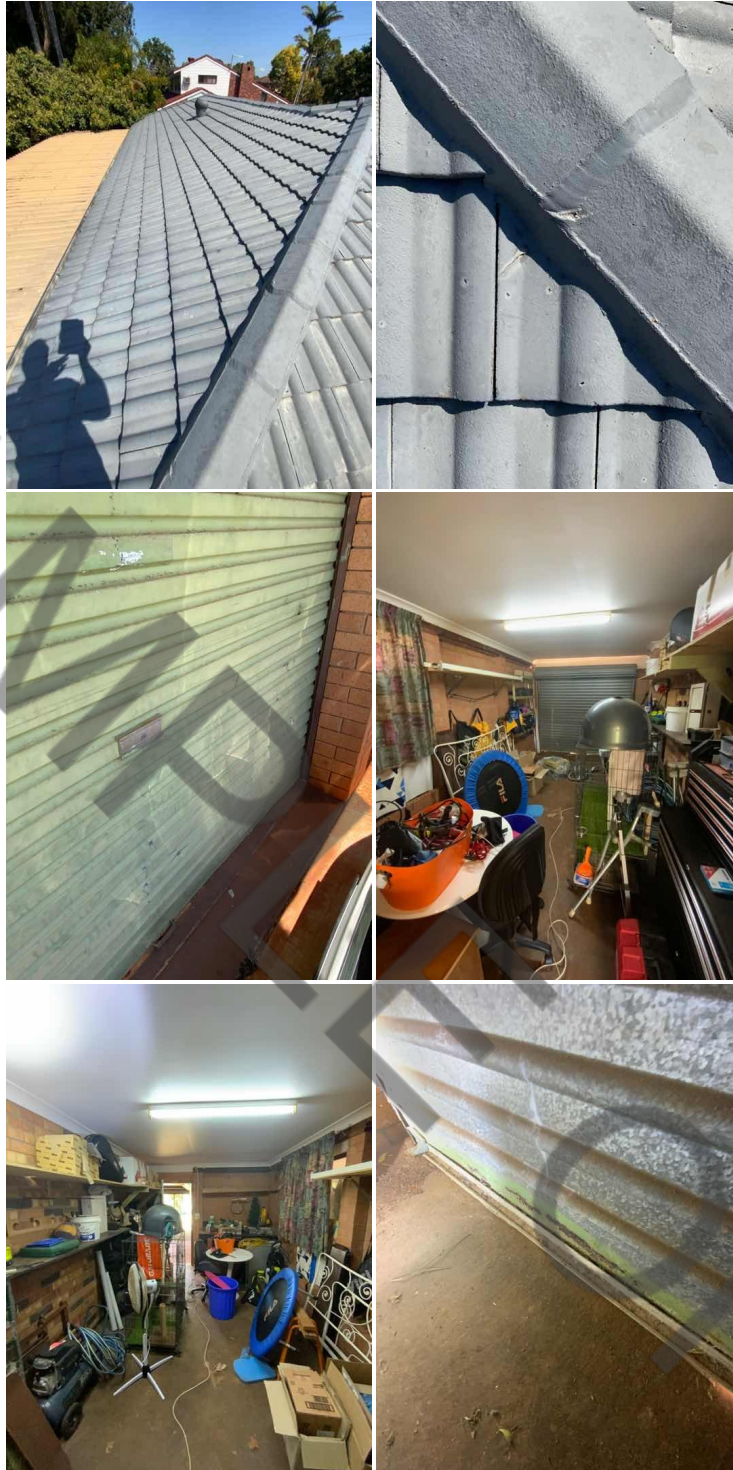
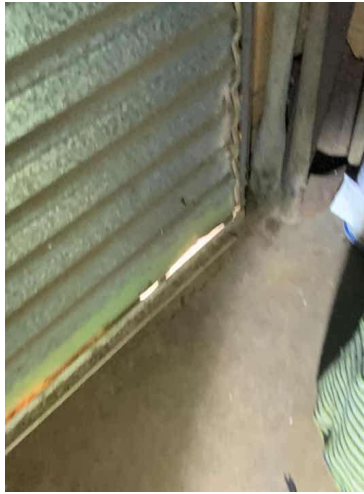
- Minor cracking to garage floor
- Minor impact damage garage door
- Excessively stored items restricted inspection
- No access to walls
- Rust to garage door

The expected consequence of the cracking can not be fully determined within the scope of a pre-purchase visual inspection. Therefore, it is recommended that a Structural Engineer be consulted to determine the expected consequence of the cracking. You can not quantify degree of movement through visual inspection, further investigation is required. When efflorescence is noted or differential colouring to bricks or concrete is noted further investigation is required to determine whether rising damp is the issue and needs resolving. Fretting of brickwork can be a result of moisture decaying the brick further investigation is required. Consult Builder for further advice cost of repairs before you make your purchase. Garages or not checked for correct electrical wiring- this needs to be checked by a qualified electrician, refer to section 5.9 on the report for further details.

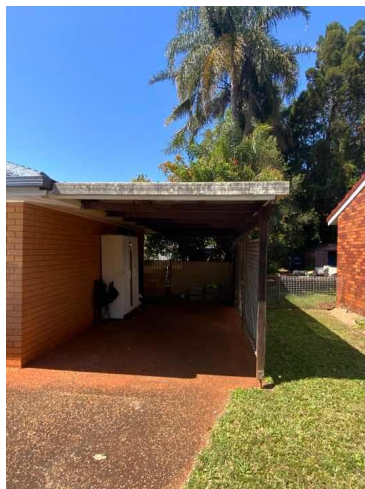
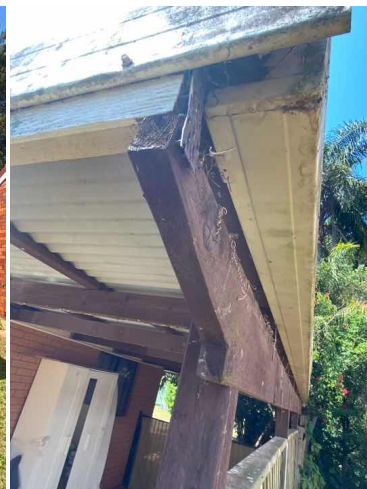
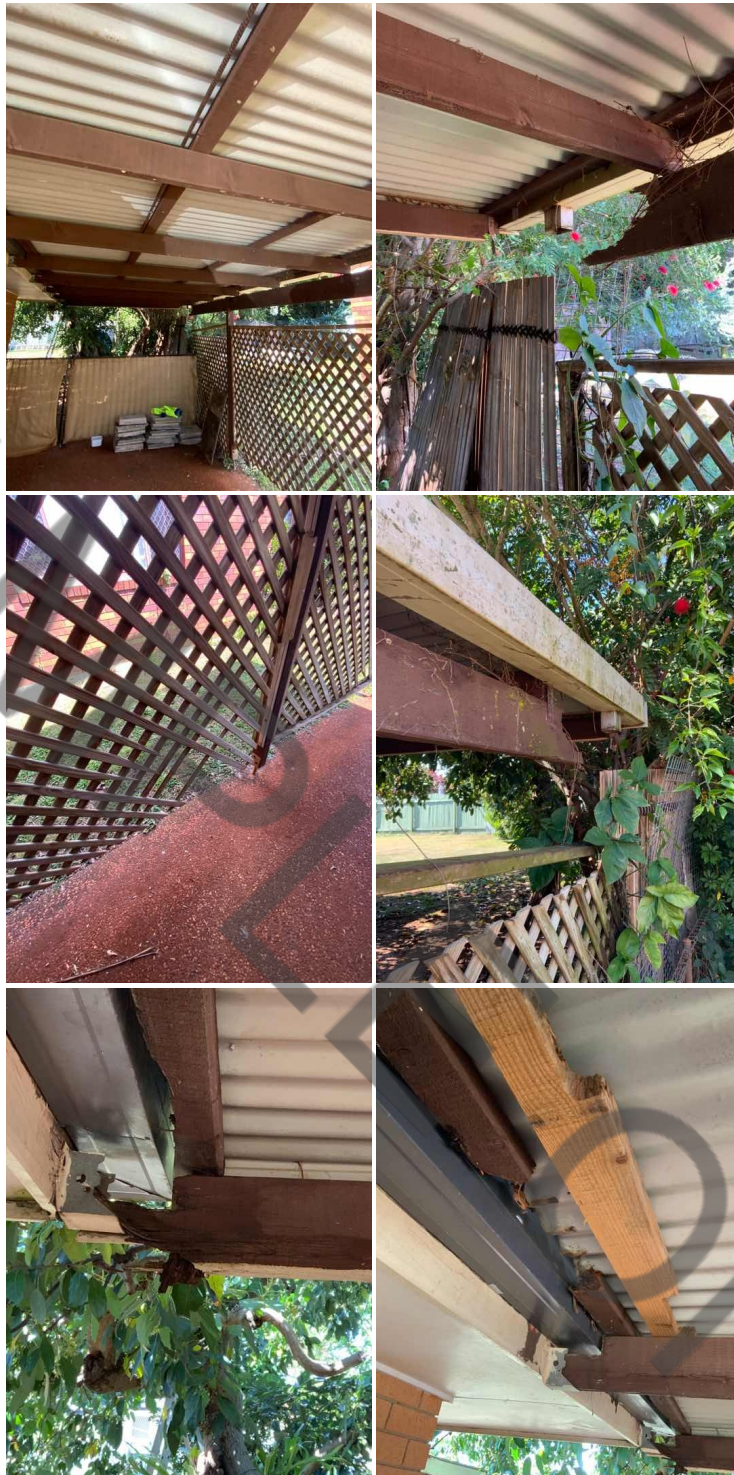
Damage to downpipe missing
 Section rotten and missing
 Rot to timbers
 Recommend replacement
 Repairs recommended

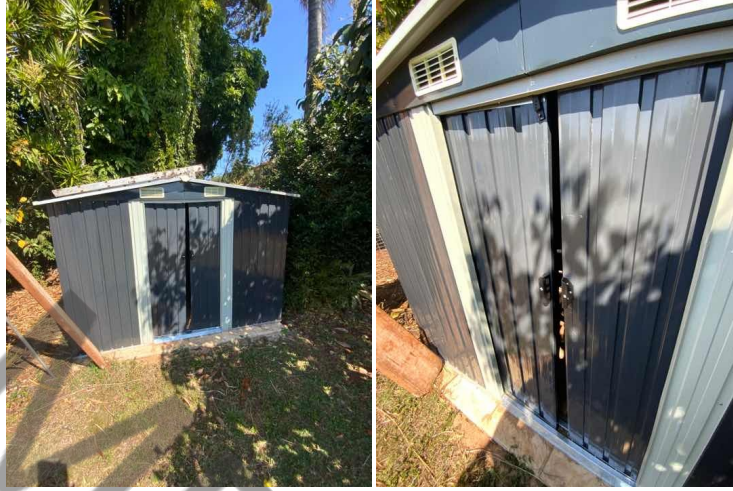
Door not sliding correctly

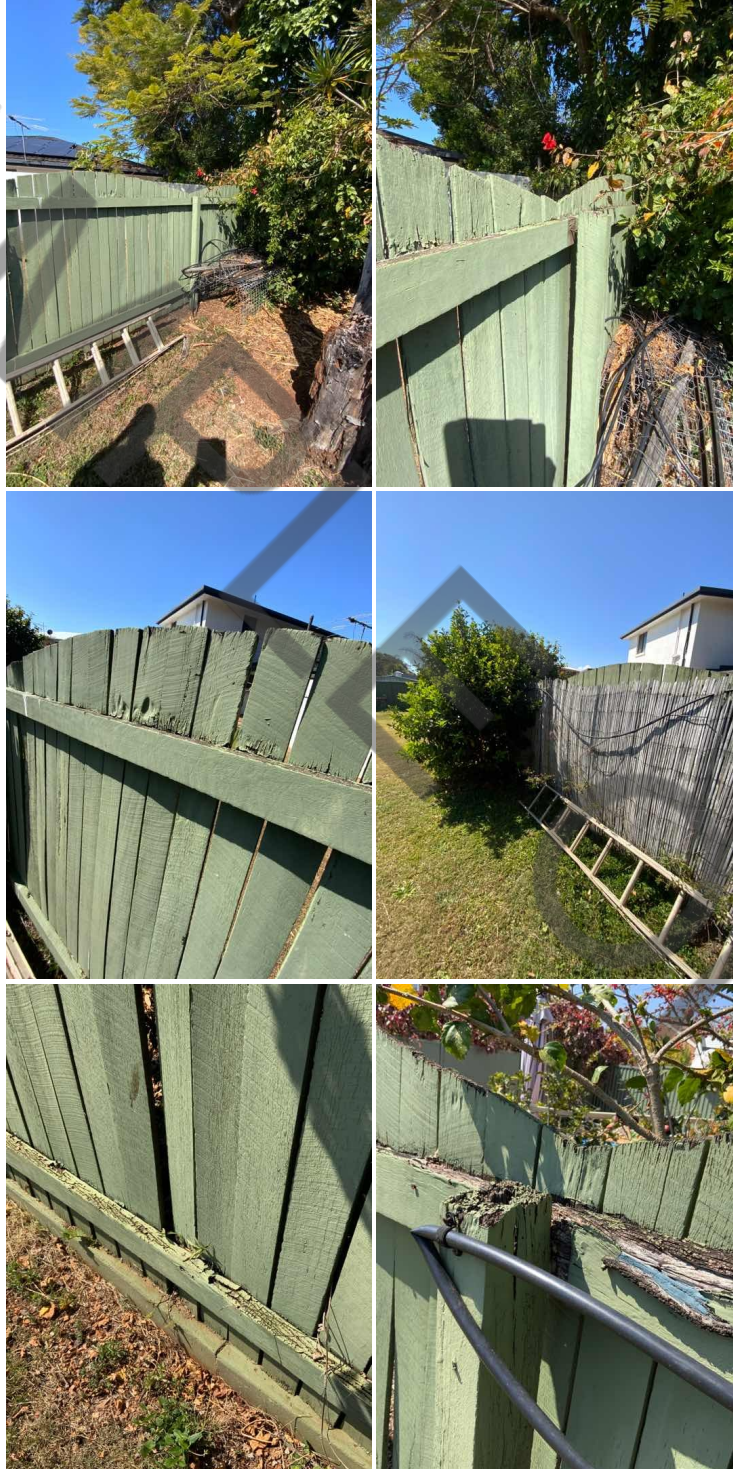
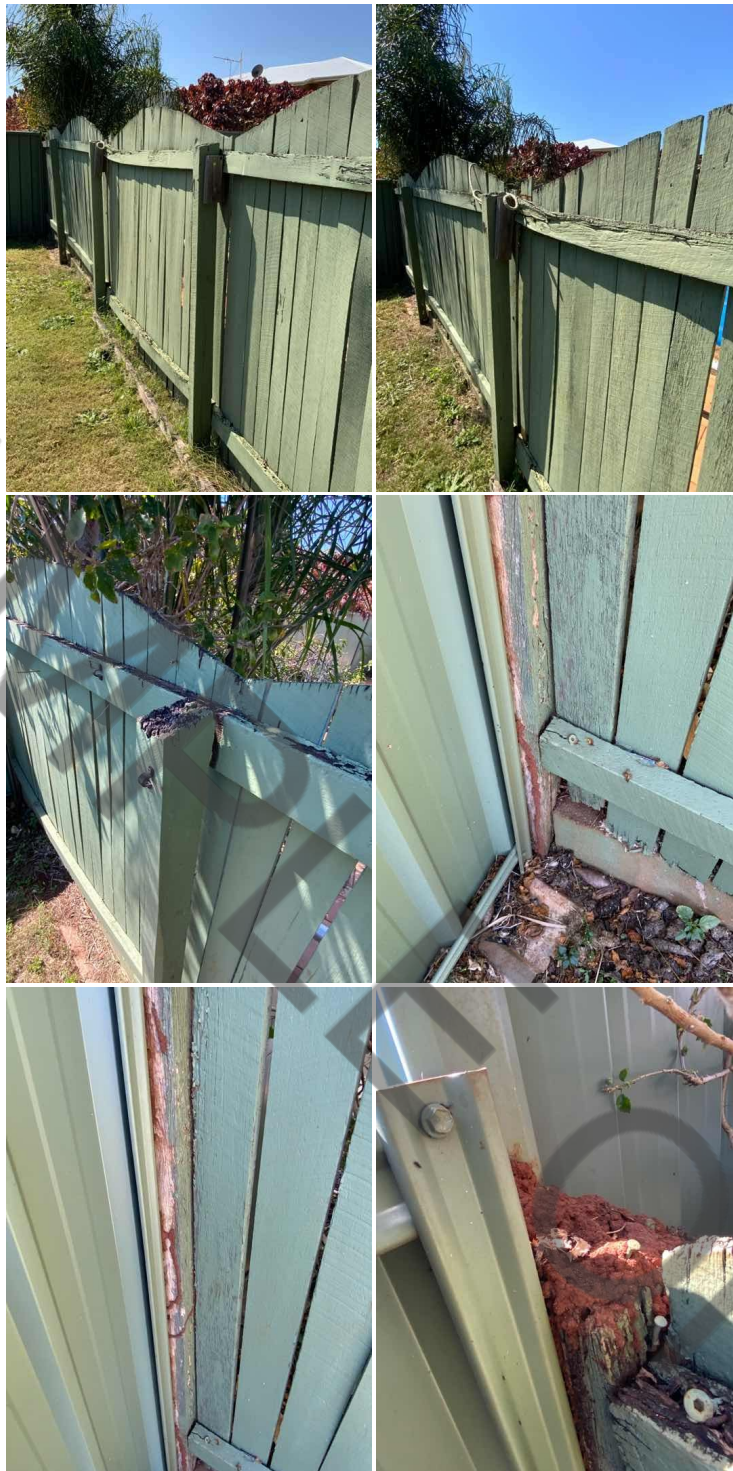
- Rot to fence timbers
- Rot to base of timber posts
- Loose fixings to fence
- Fence wobbles
- Termite damage to timbers
- Restricted access due to vegetation
- Repairs recommended
- Recommend replacement

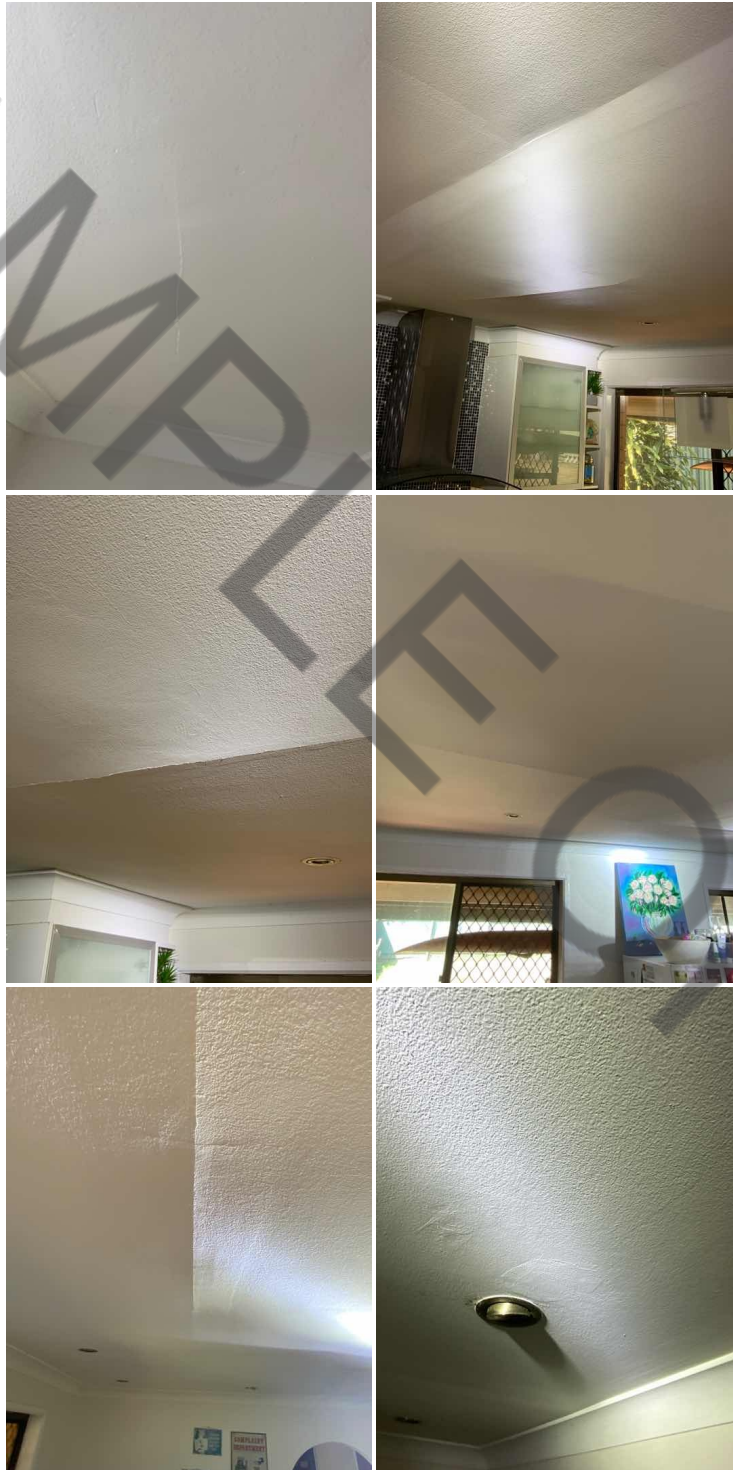
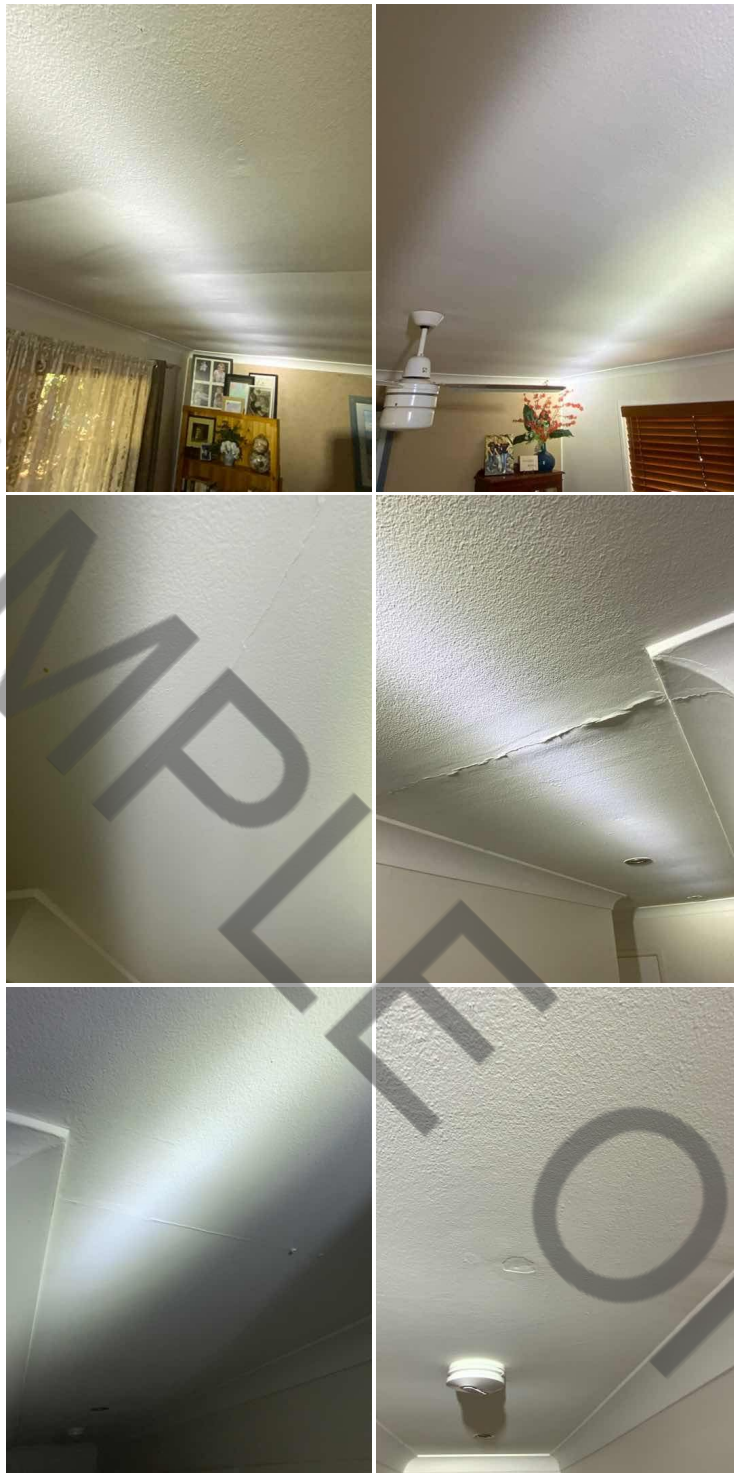
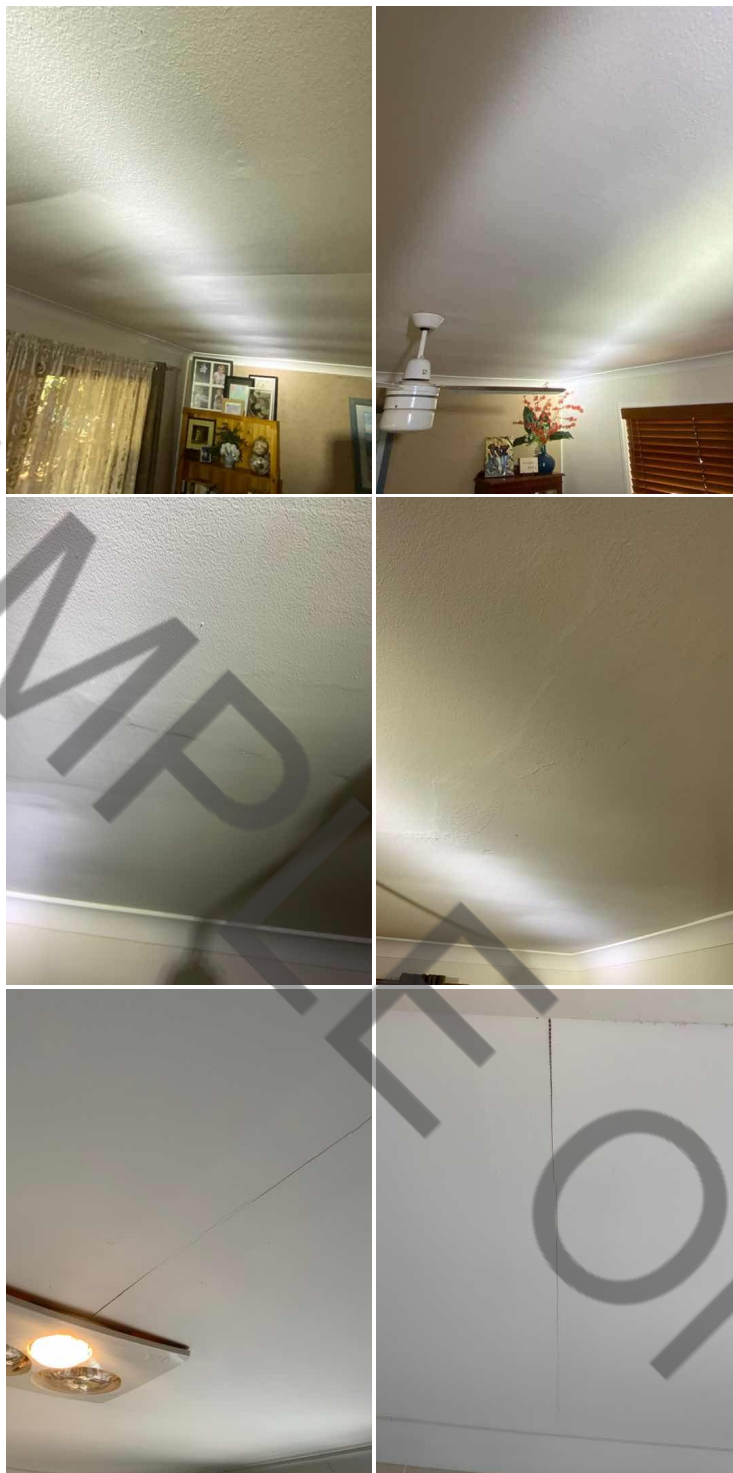
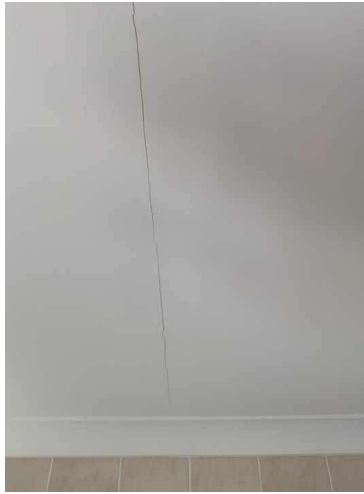
- Cracking throughout ceiling in areas
- Nail heads popped/penetration sheeting
- Areas of Delaminated Sheeting in kitchen area
- Patch repairs to ceiling
- Paint Stress To Ceilings
- Further investigation recommended
- Repairs recommended

When areas of ceiling have delaminated from roof framing – we recommend rescrewing and any exposed nail heads should be filled when next painting. Cracking to plaster ceiling can often be overcome by the use of expansion joints. F C sheeting prior to 1990 may contain asbestos therefore an asbestos audit is recommended. Any repairs or maintenance of asbestos products should only be undertaken by professionals trained in handling of asbestos. Asbestos products should be kept painted and sealed to eliminate air borne fibres

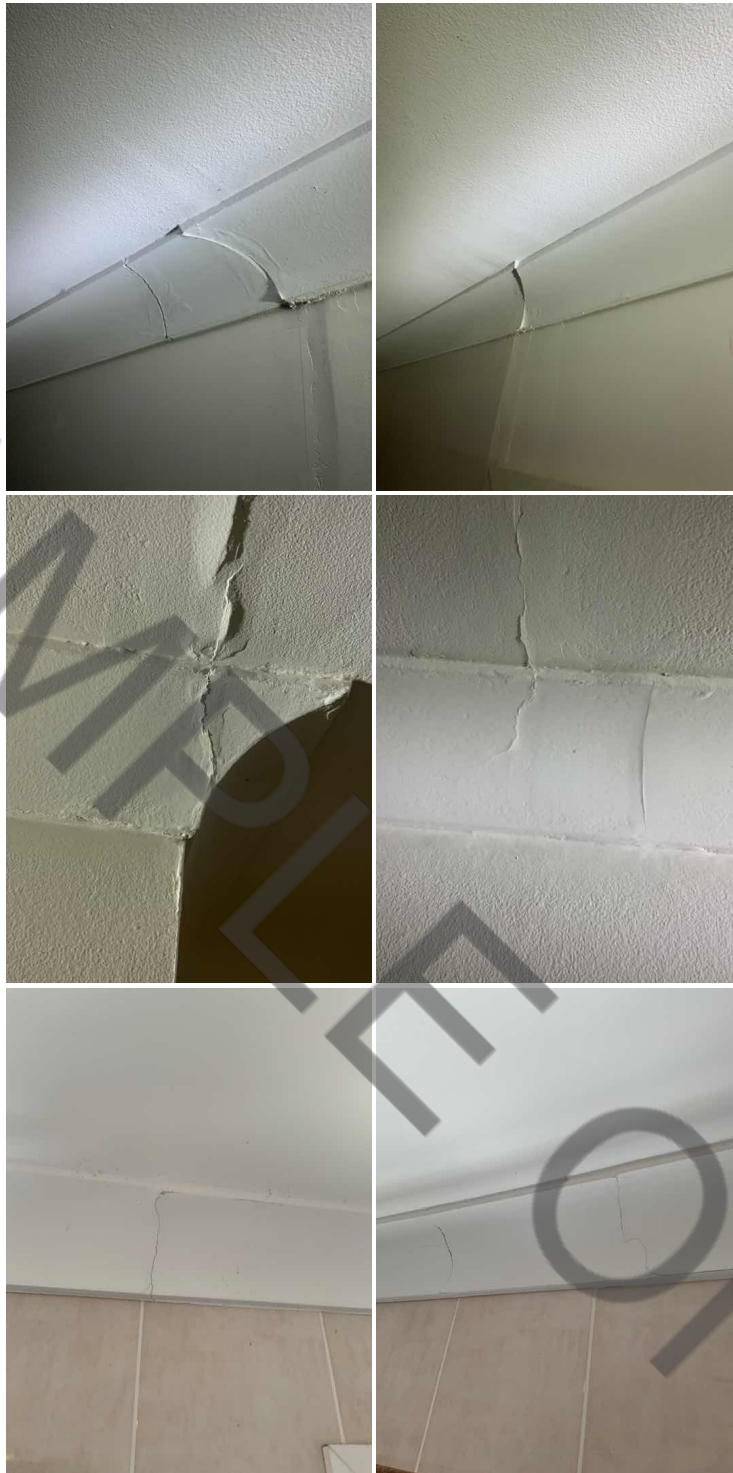
Minor cracking to cornice joins
 Minor cracking through cornice
 Patch repairs to cornice
 Maintenance required

Minor cracking to the plaster/cornice are caused by minor building movement and settling and do not represent a long-term structural problem.

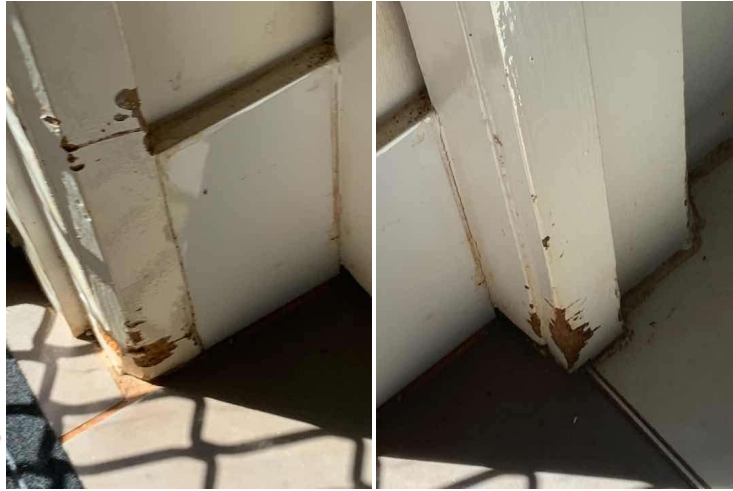
Minor separation of skirting from wall
Damaged architrave
Further investigation recommended
Maintenance required

Defects should be referred builder for costing before you make your purchase. Timber rot or any termite damage will require a timber pest inspection and advice from a qualified pest inspector and also Builder for costing of repairs before you make your purchase, Invasive inspection is recommended to confirm extent of any damage.

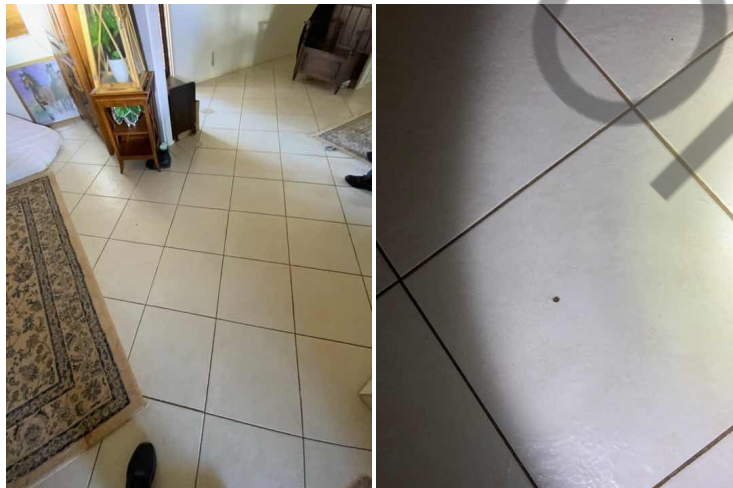
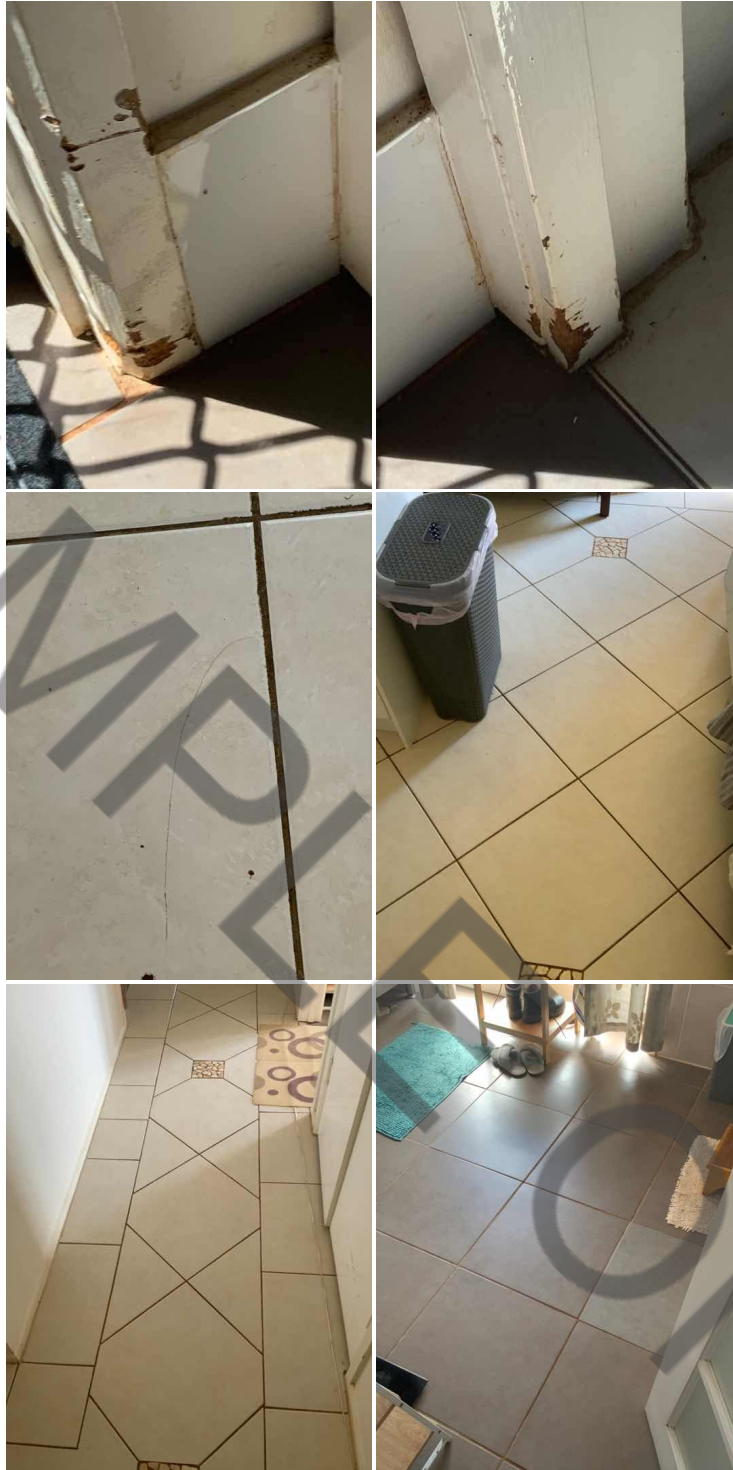
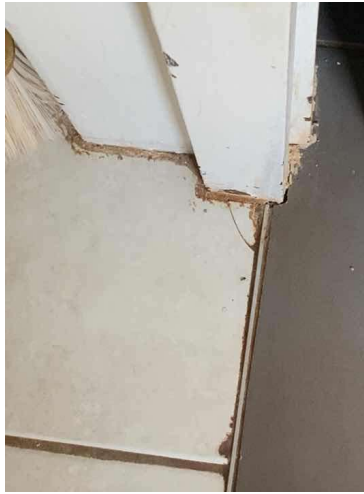
Cracking to tiles
 Minor evidence of drummy tiles
 Chipped tiles to floor
 No control/expansion joints to tiled floor
 Different colour replaced tile bathroom
 Further investigation recommended
 Maintenance Required

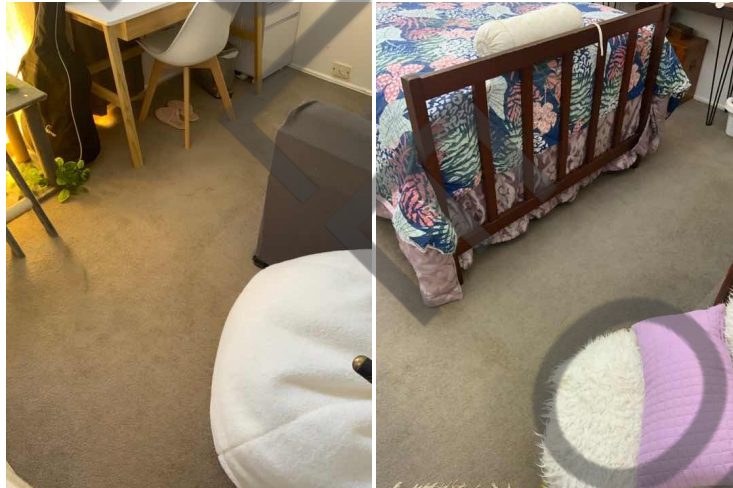
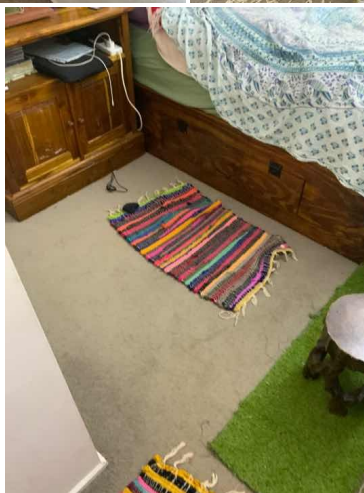
General deterioration to carpet

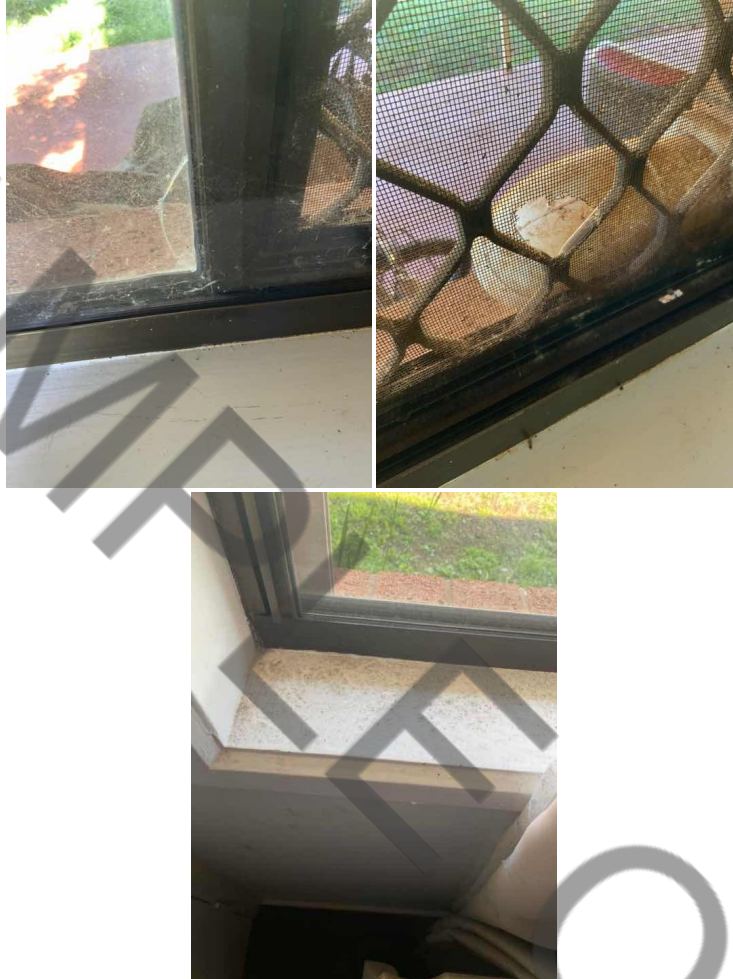
- Recommend servicing of rollers
- Minor cracking to window glass
- Mould to window
- Damage fly screens
- Further Investigation Recommended
- Maintenance Required

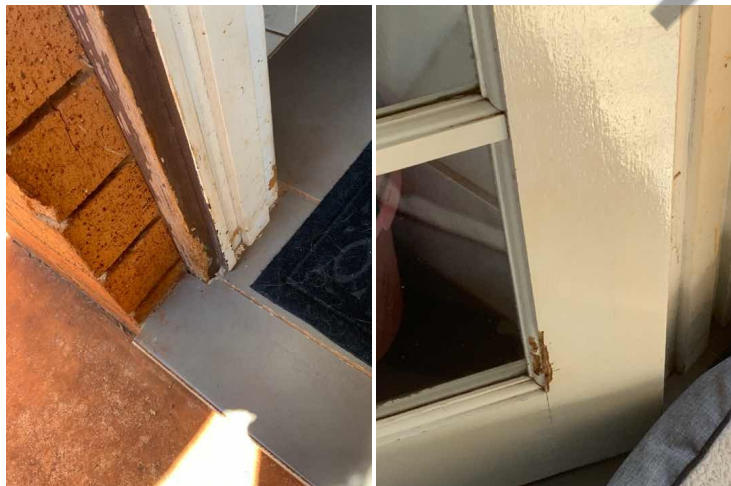
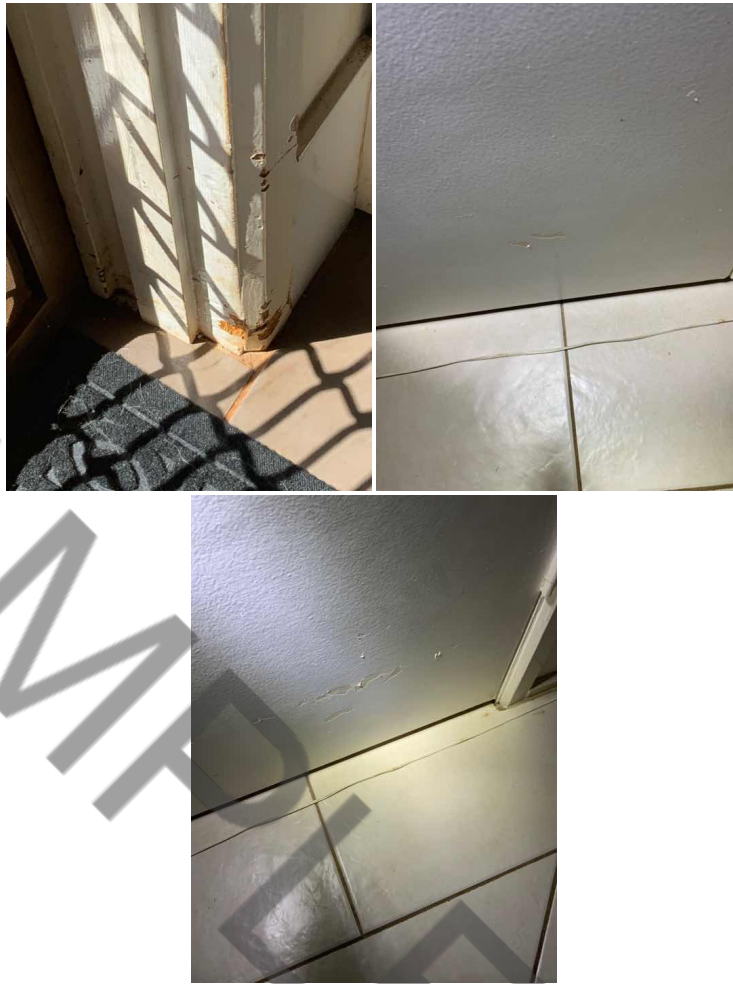
Recommend servicing of rollers
Paint stress
Damage to door frame
Animal damage door frame and door
Further investigation recommended
Maintenance Required

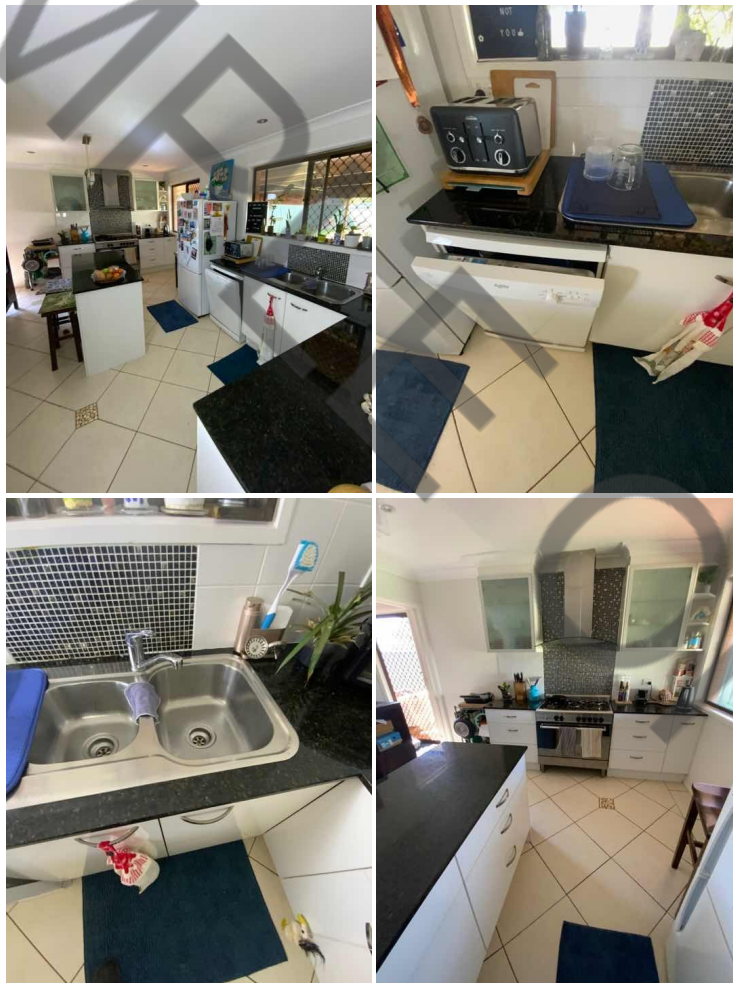
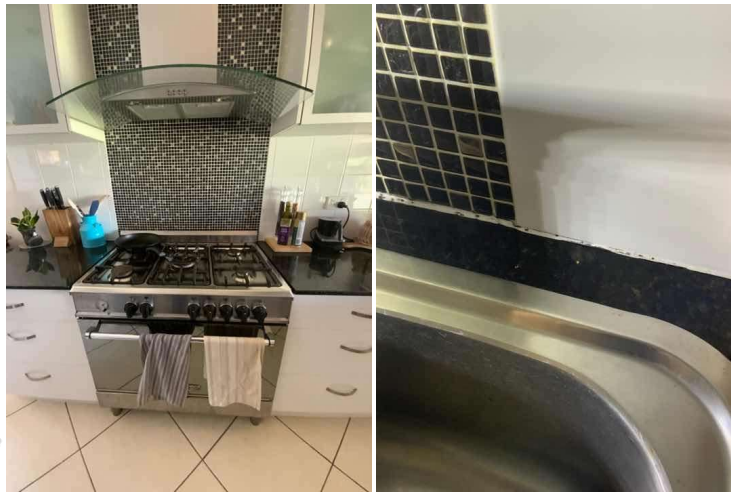
Cabinets in good to fair condition
 Recommend to reseal around kitchen benches
 Deterioration to silicone
 Maintenance Required
