Sample Building Report

Inspect Detect Consultants

Complies with Australian Standard AS 4349.1-2007 Inspection of Buildings Part 1: Pre Purchase Inspections – Residential Buildings – Appendix “C”

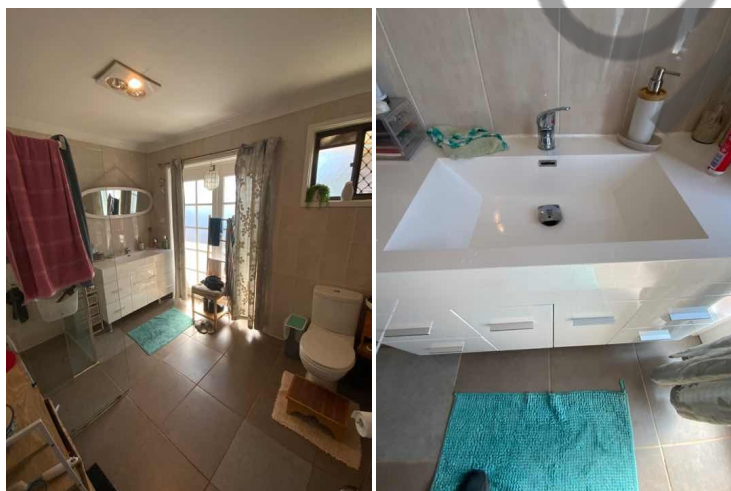
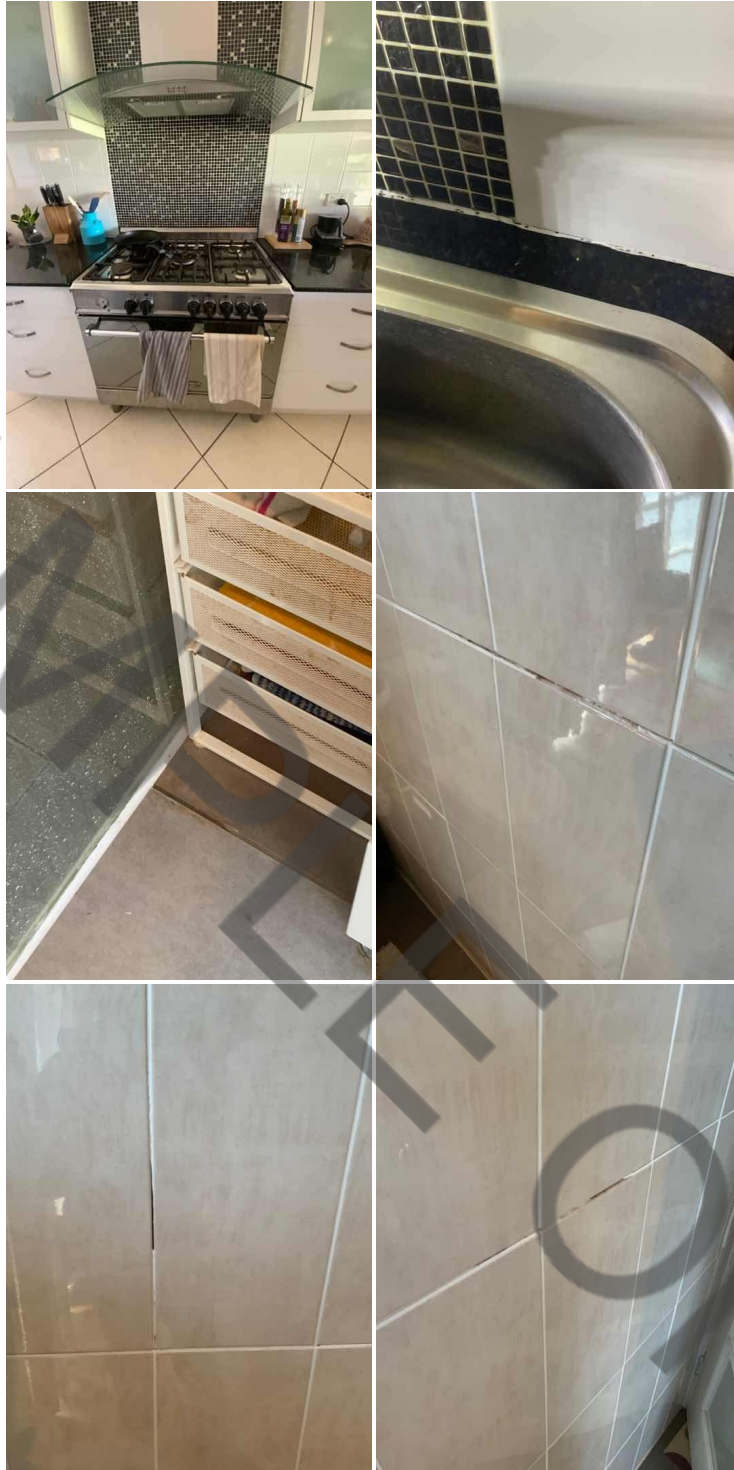
Vanity in good to fair condition
 Ensure gap between tap body and wall is sealed
 Recommend to reseal shower
 Deterioration to silicone - recommend to reseal
 Missing grout to tiles and loose tiles wall
 Minor leak to shower screen - Reseal joins
 Recommended bathroom renovation
 Further investigation recommended
 Repairs recommended

Always ensure any gaps between the tap bodies and shower recess are sealed with silicone sealant to ensure that a water penetration does not occur to the cavity of the wall. Joins at rear and sides of shower recess/es, bathtub, and vanity/ies should be kept well sealed to prevent water penetration behind cabinet construction. Heavily stored items in cupboards – restrict the inspector from a full inspection. No inspection under or behind Vanity cupboards.

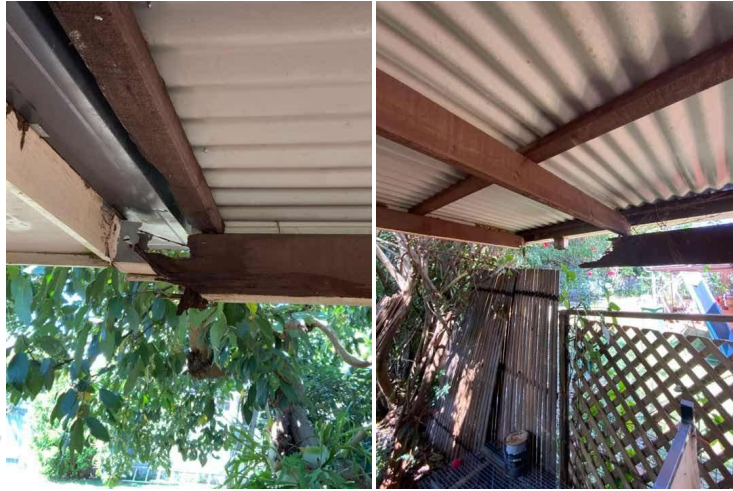
Rot to carport timbers
Immediate action is required

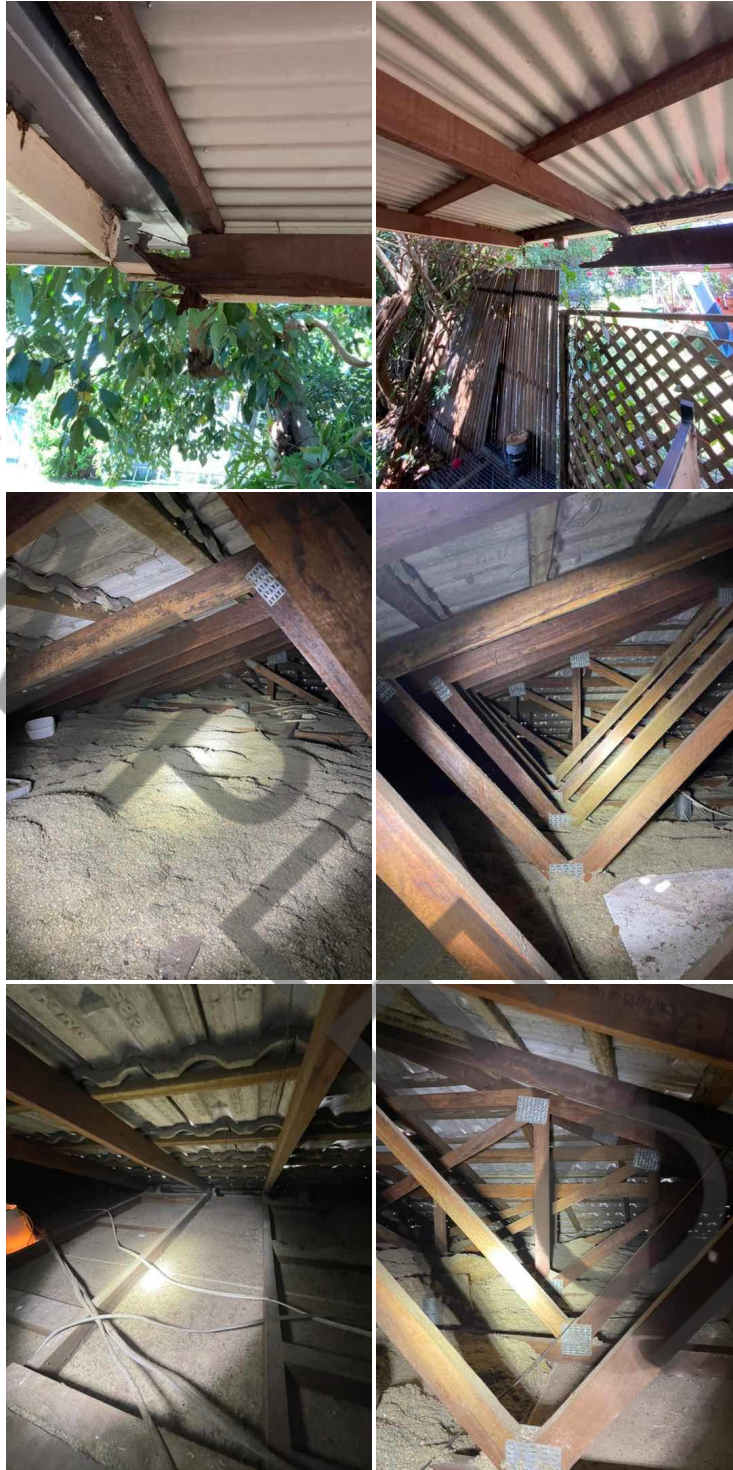
Restricted access
 Construction method has restricted inspection
 No access to external top plates
 Ceiling insulation restricted inspection
 Recommend installation of manhole
 Further investigation recommended
