Sample Timber Pest Report

Inspect Detect Consultants

Sample

Inspection Date: 01 Sep 2021

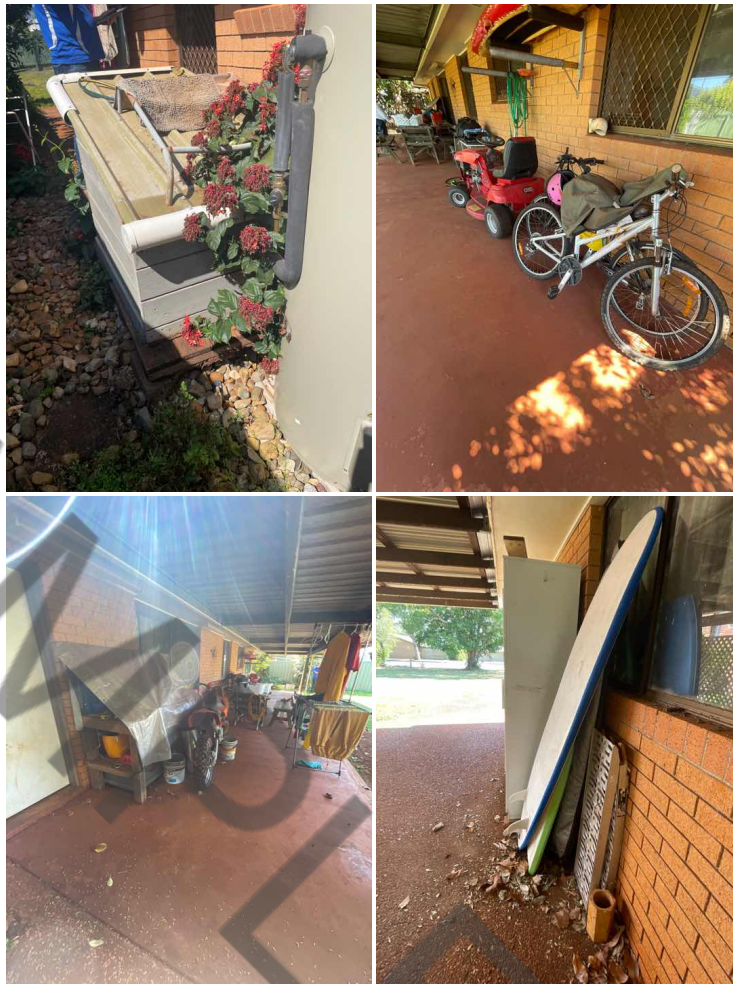
Building Exterior:

Yes
Stored items restricted the inspection
Further Investigation Recommended

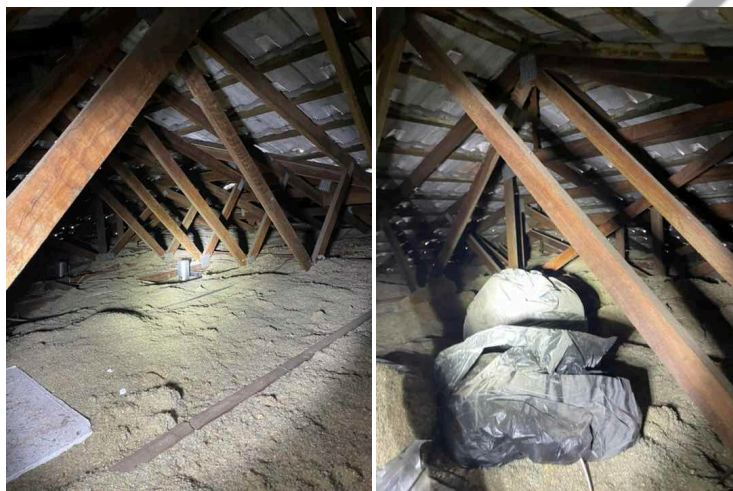
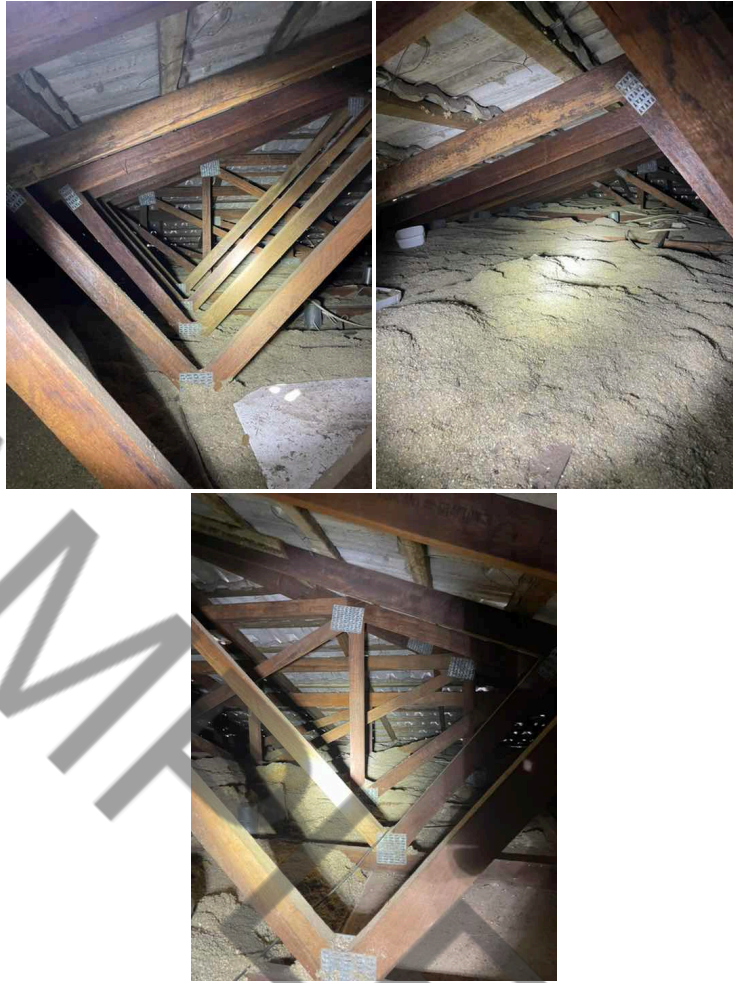
Roof Void:

- Yes
- Restricted access
- Construction method restricted the inspection
- No access to external top plates
- Ceiling insulation restricted the inspection
- Low roof pitch restricted the inspection
- Recommend installation of another manhole
- Further investigation required

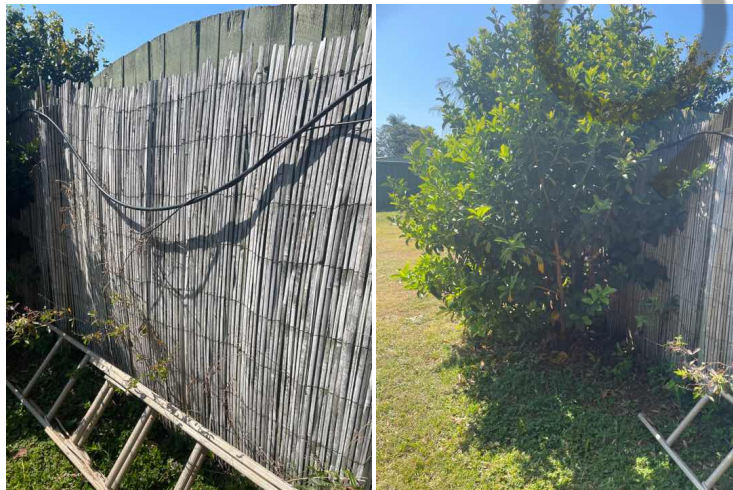
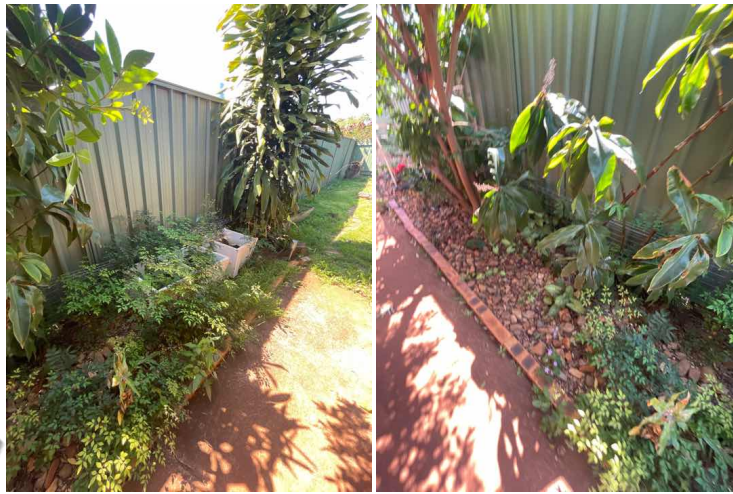
Site:

Fence Coverings Restricted Inspection

Further investigation recommended

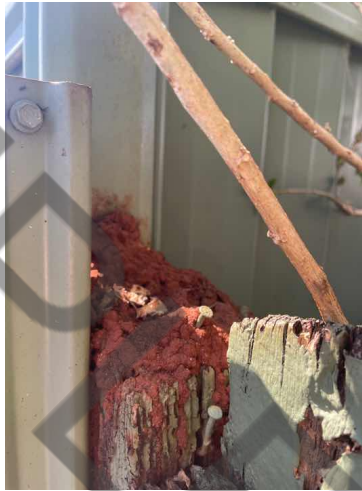
Was a termite nest found?

Yes

Further Investigation Recommended

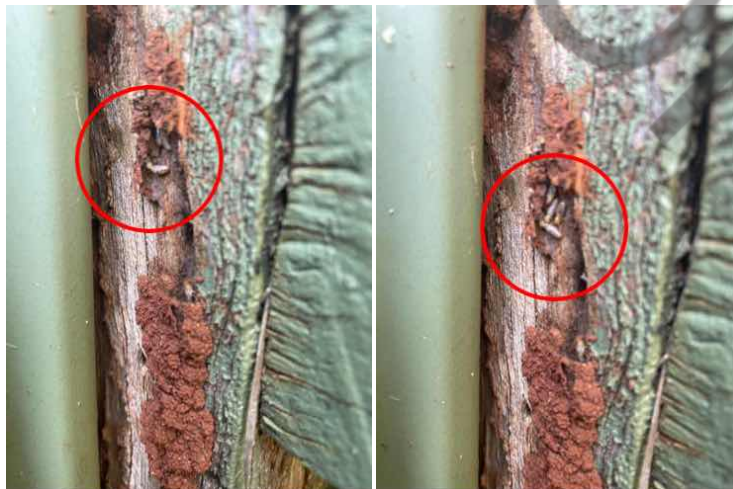
Active (live) Termites were located but not limited to the following areas

Timber fence

(Microcerotermes sp) This species of termite has the potential to cause **minor to moderate** damage to structural and decorative timbers

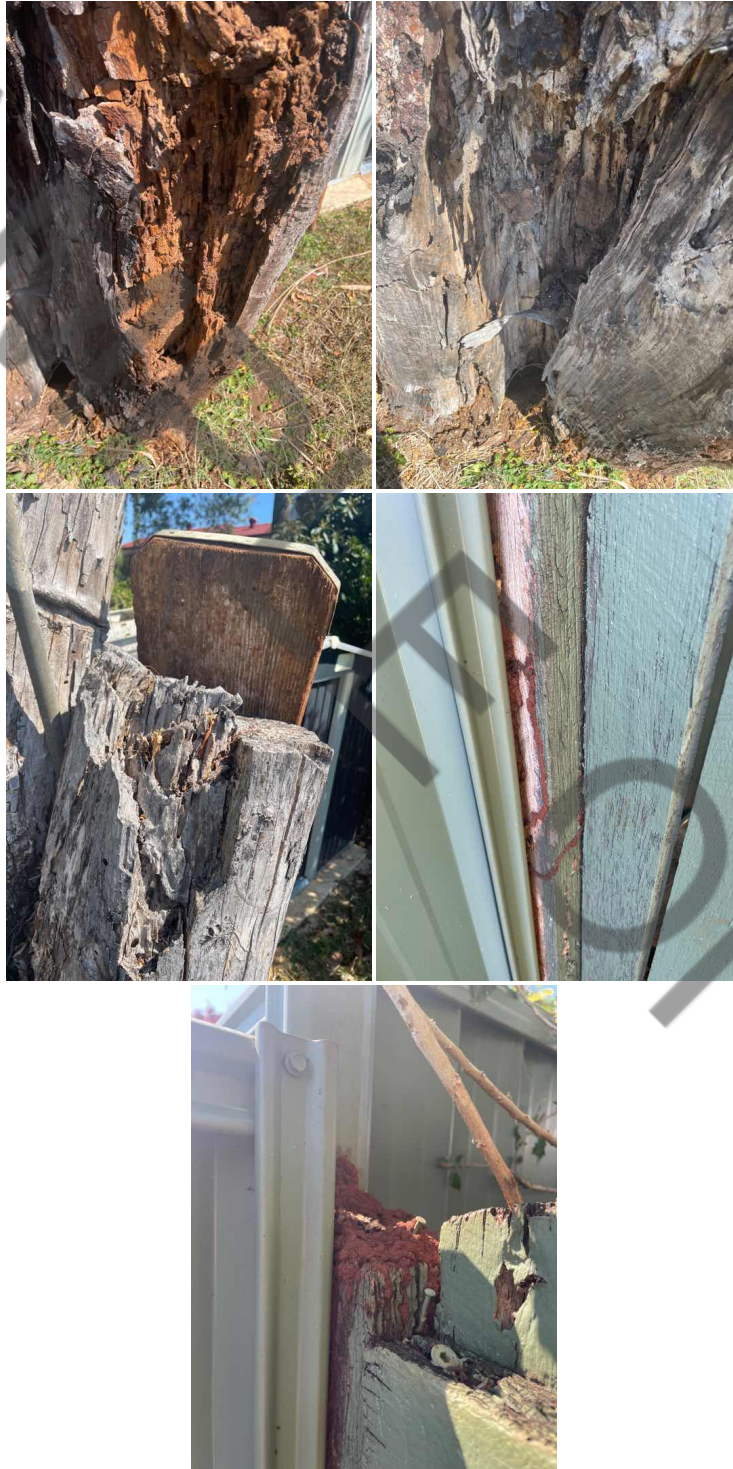
Termites workings/Damage was located but not limited to the following areas

Timber fence

Tree Stumps

RECOMMENDATION Where evidence of damage to building timbers exists, competent advice (e.g. from a licensed and practicing building contractor) should be obtained to determine the extent of any structural damage and as to the need or otherwise for rectification or repair work. See also Item 3.5 'Frequency of Future Inspections' recommendation. When replaced timbers have been noted the owner is to be consulted for further information

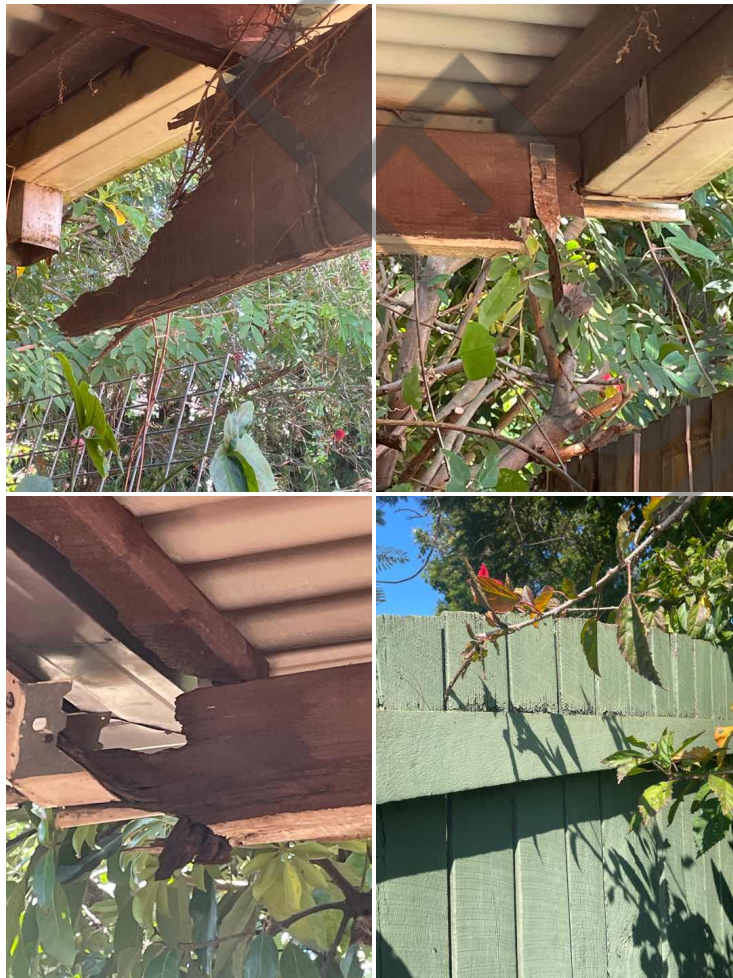
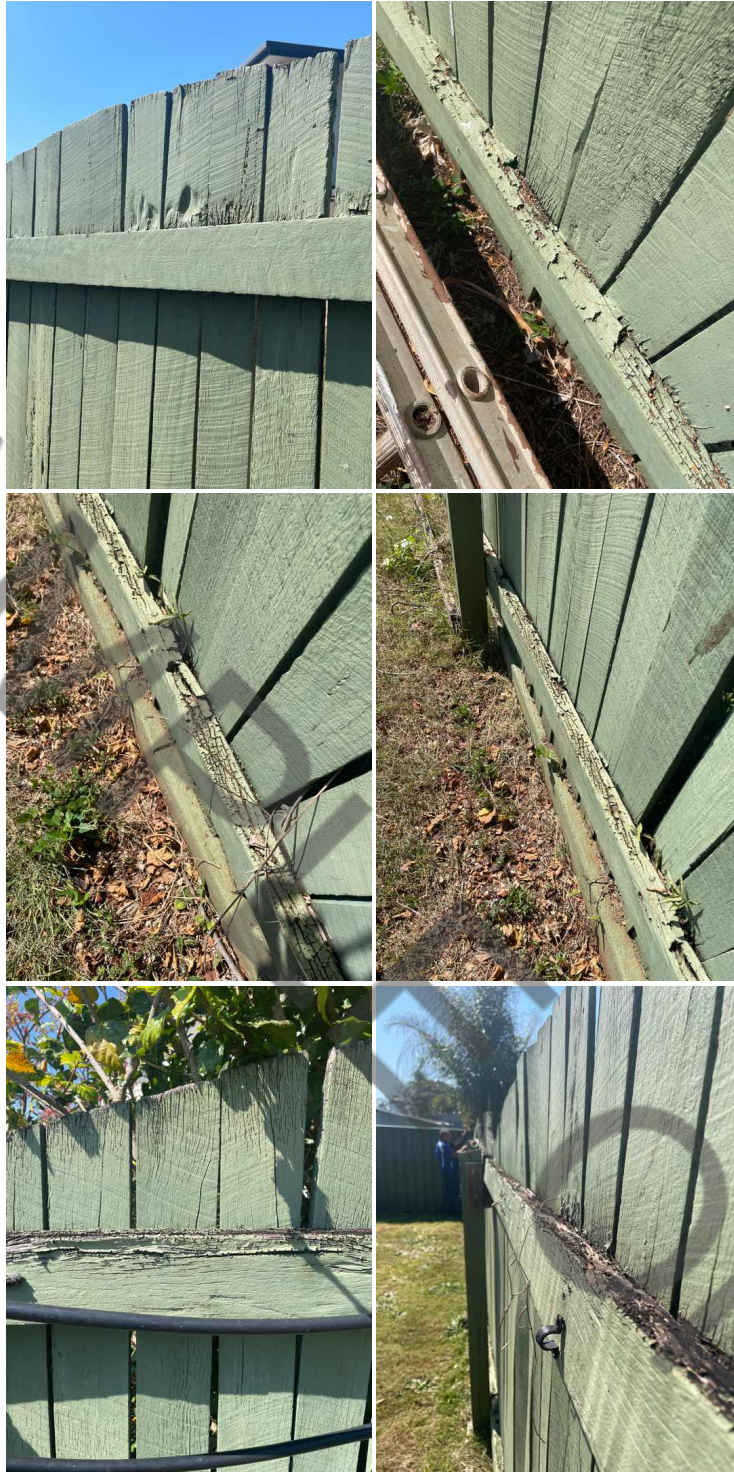
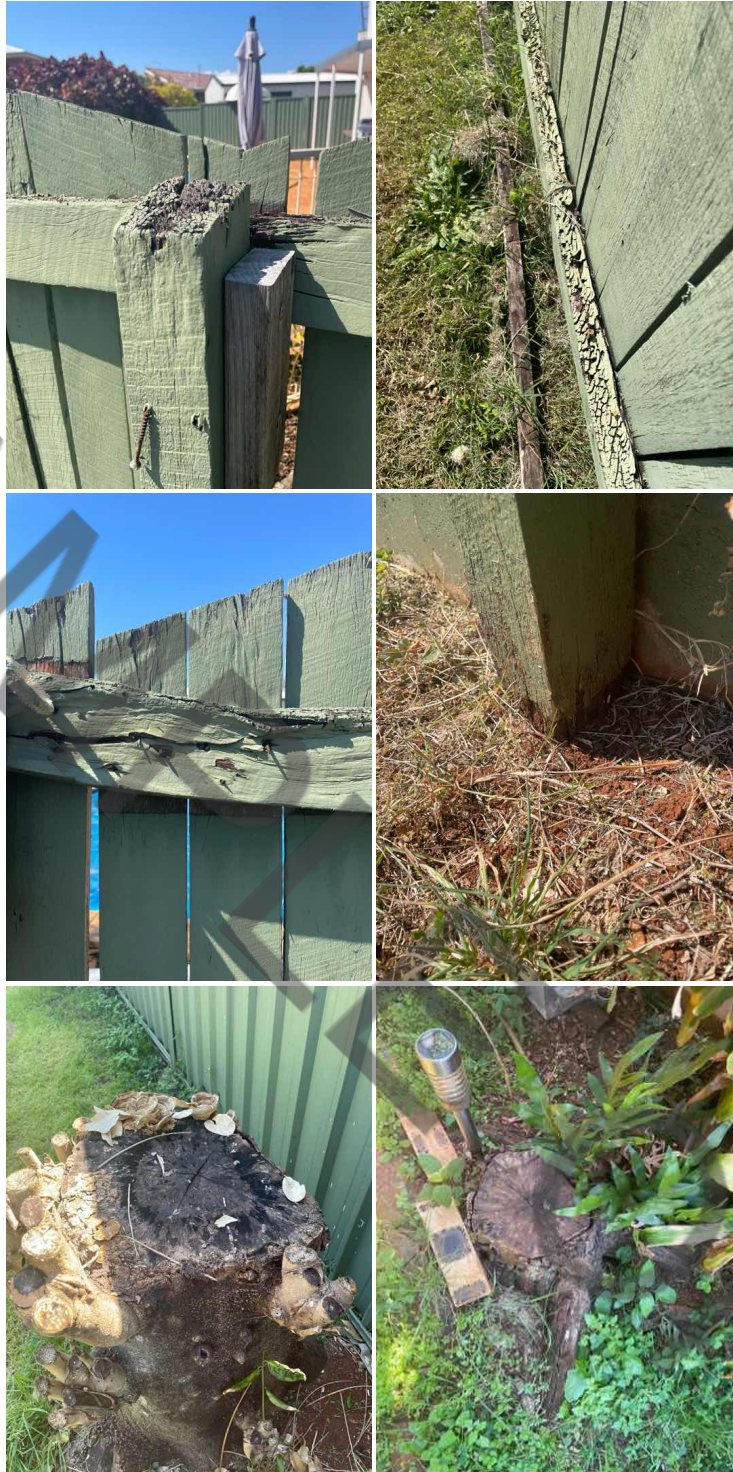
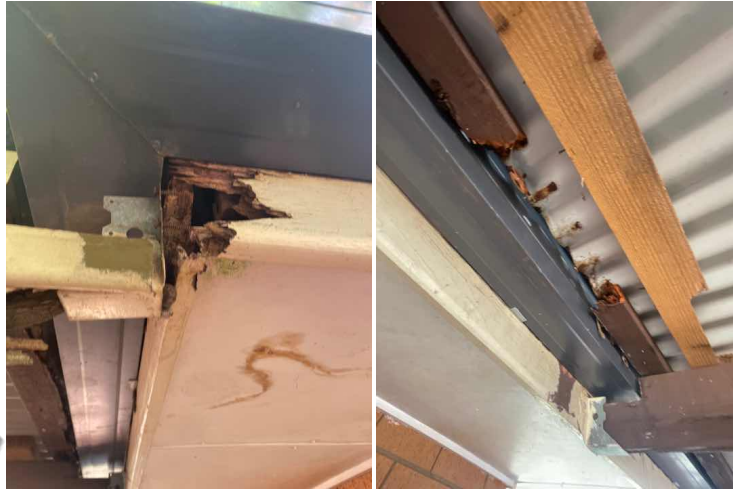
Was evidence of Fungal Decay found?

Further investigation recommended

Repairs recommended

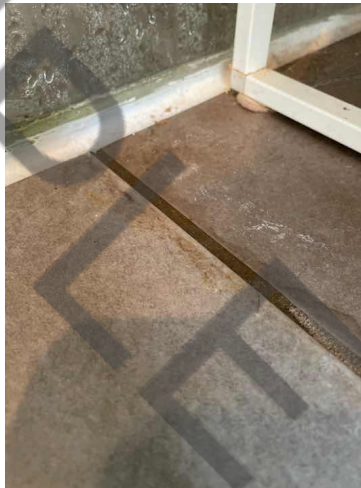
Were water leaks present?

Repairs required

Further Investigation Required

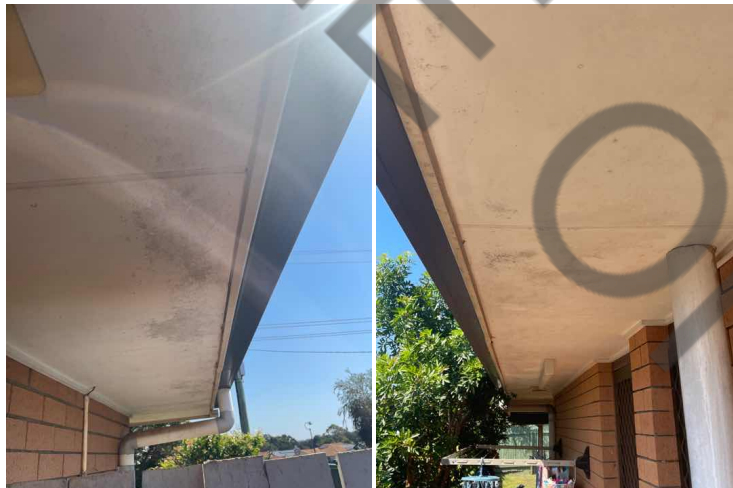
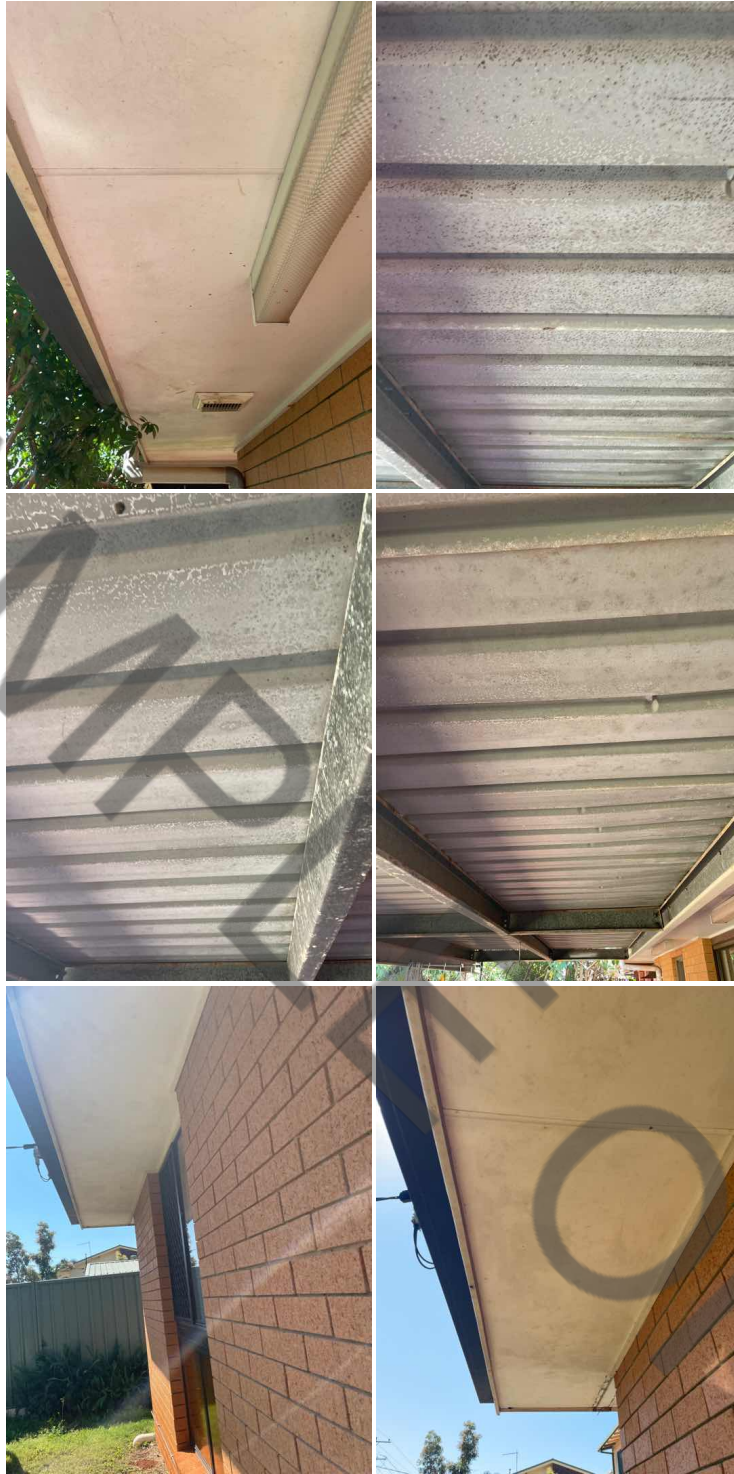
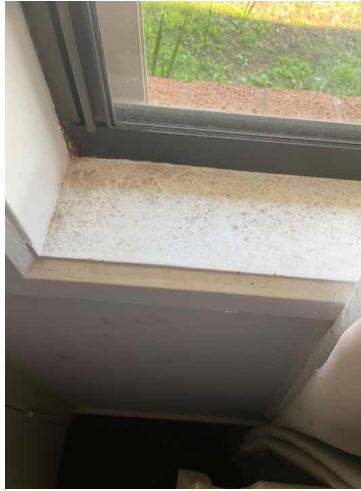
Was Mould found at time of inspection?

Eaves sheeting
Pergola roof sheeting
Window frame
Maintenance required

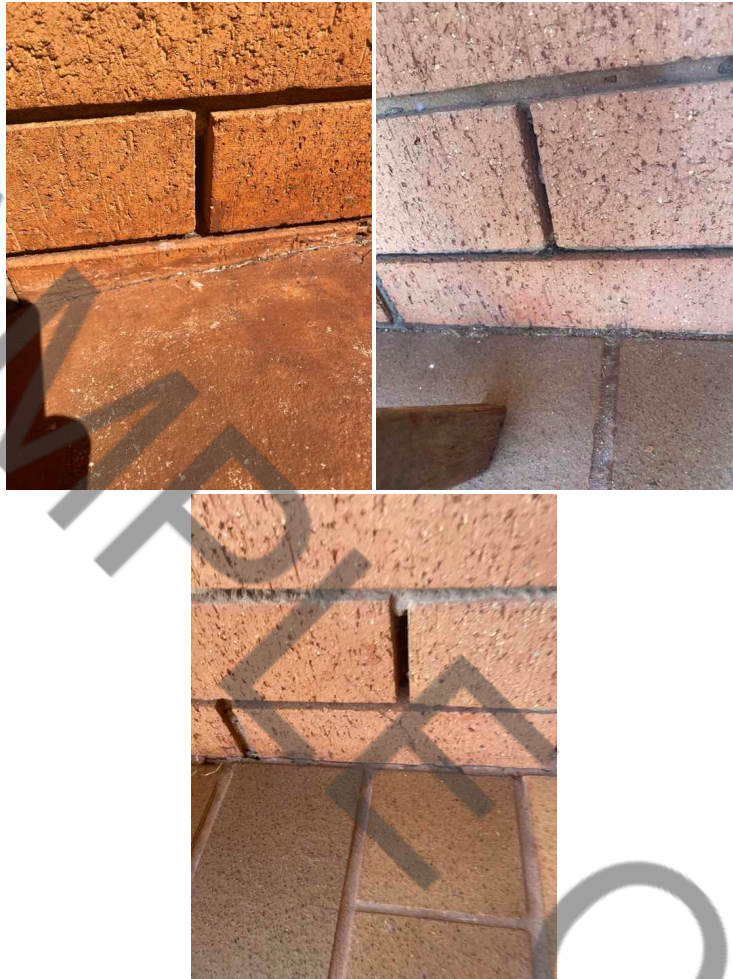
Yes

If yes, a minimum inspection zone of 75mm must be maintained (see also Clauses A.7 and A.8)

It is very important that soil, lawn, concrete paths or pavers do not cover the weep holes. Sometimes they have been covered during the rendering of the brick work. They should be clean and free flowing. Covering the weep holes in part or in whole may allow undetected termite entry, 75 mm inspection zone is recommended to be maintained.

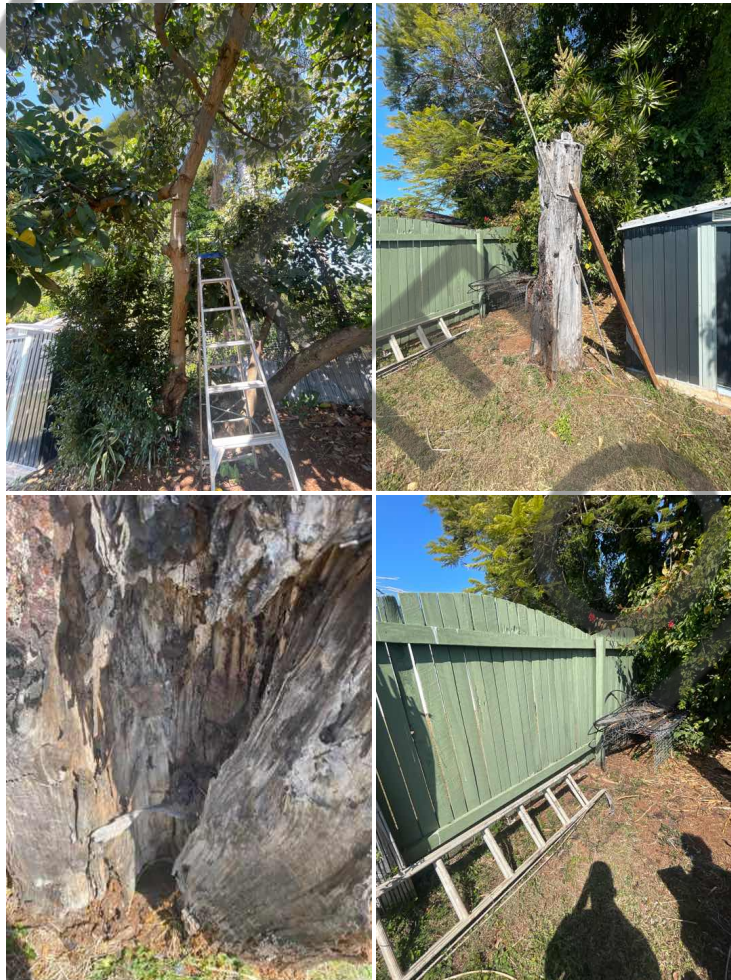
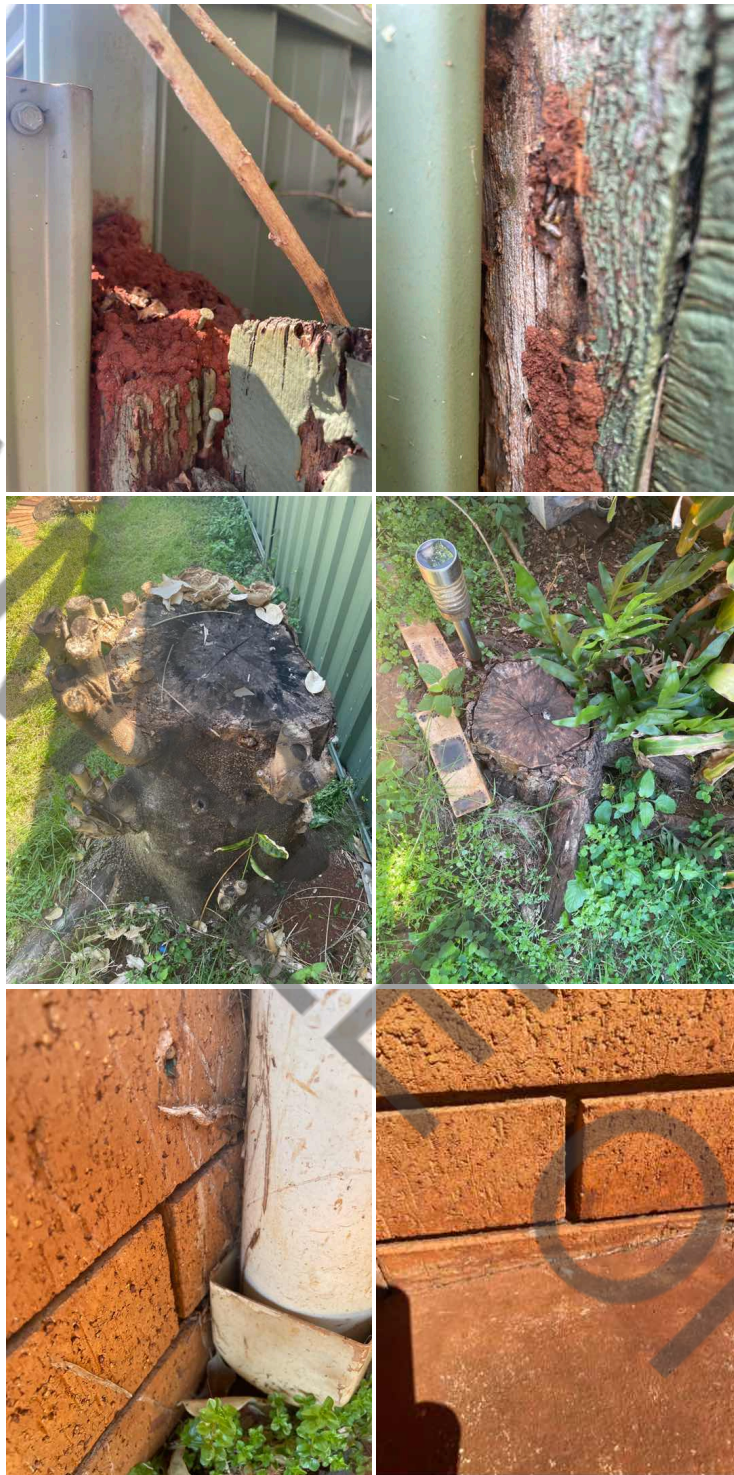
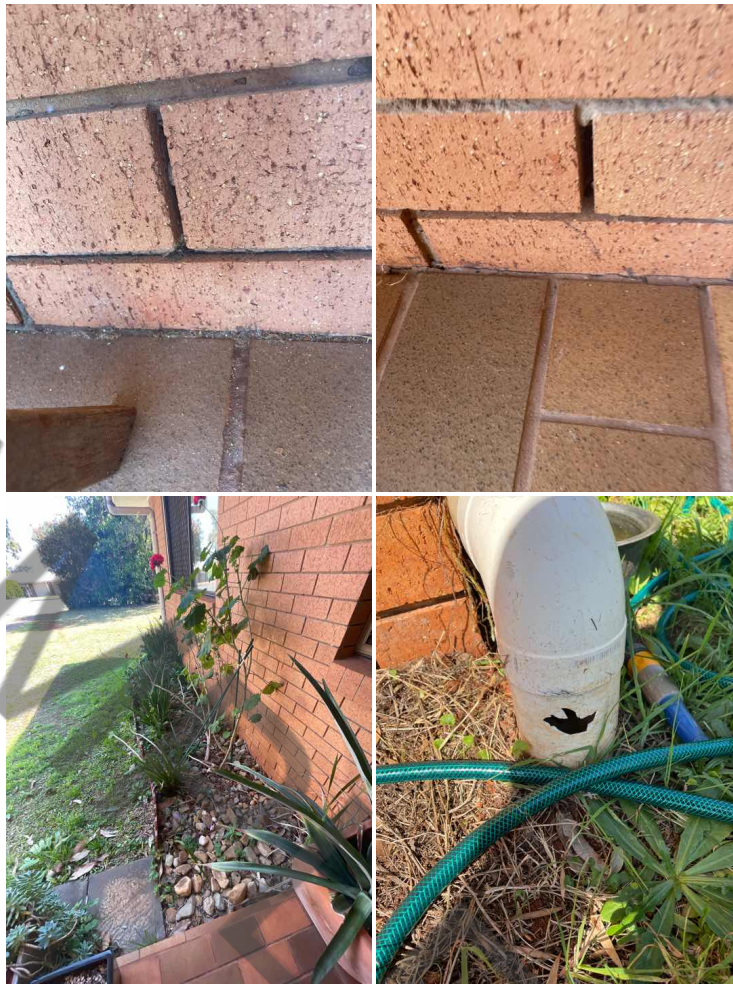
- Concrete slab on ground construction
- Weep holes without a min 75mm clearance
- Downpipes releasing water next to dwelling
- Plants and gardens next to dwelling
- When previous termite attack has occurred
- When termite management program is out of date
- Tree Stumps
- Timber fences
- Trees
- Downpipes without 25mm clearance from the dwelling

Hot water services, air conditioning units which release water alongside or near to building walls need to be connected to a drain. If this is not possible then their water outlet needs to be piped several meters away from the building, as the resulting wet area is highly conducive to termites.
