Sample Building Report

Inspect Detect Consultants

Complies with Australian Standard AS 4349.1-2007 Inspection of Buildings Part 1: Pre Purchase Inspections – Residential Buildings – Appendix “C”

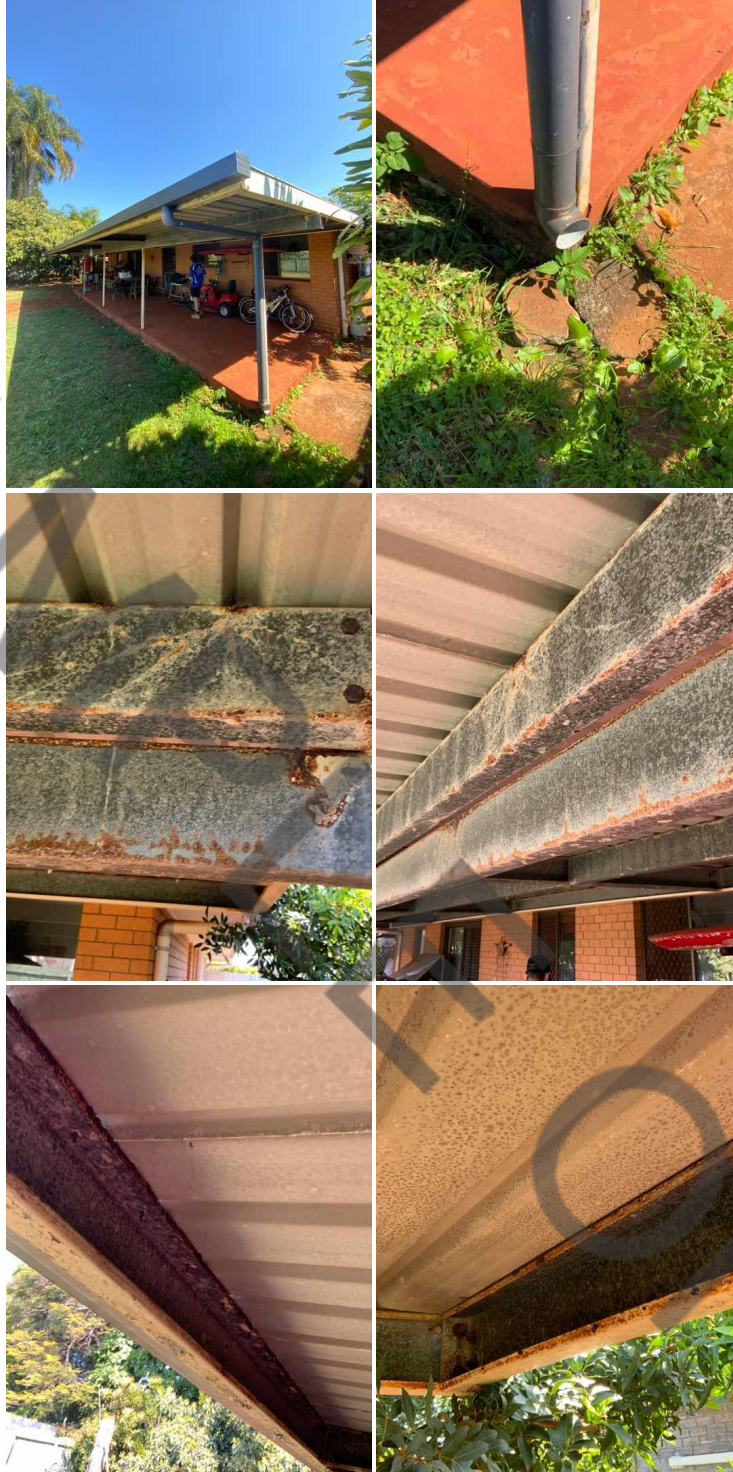
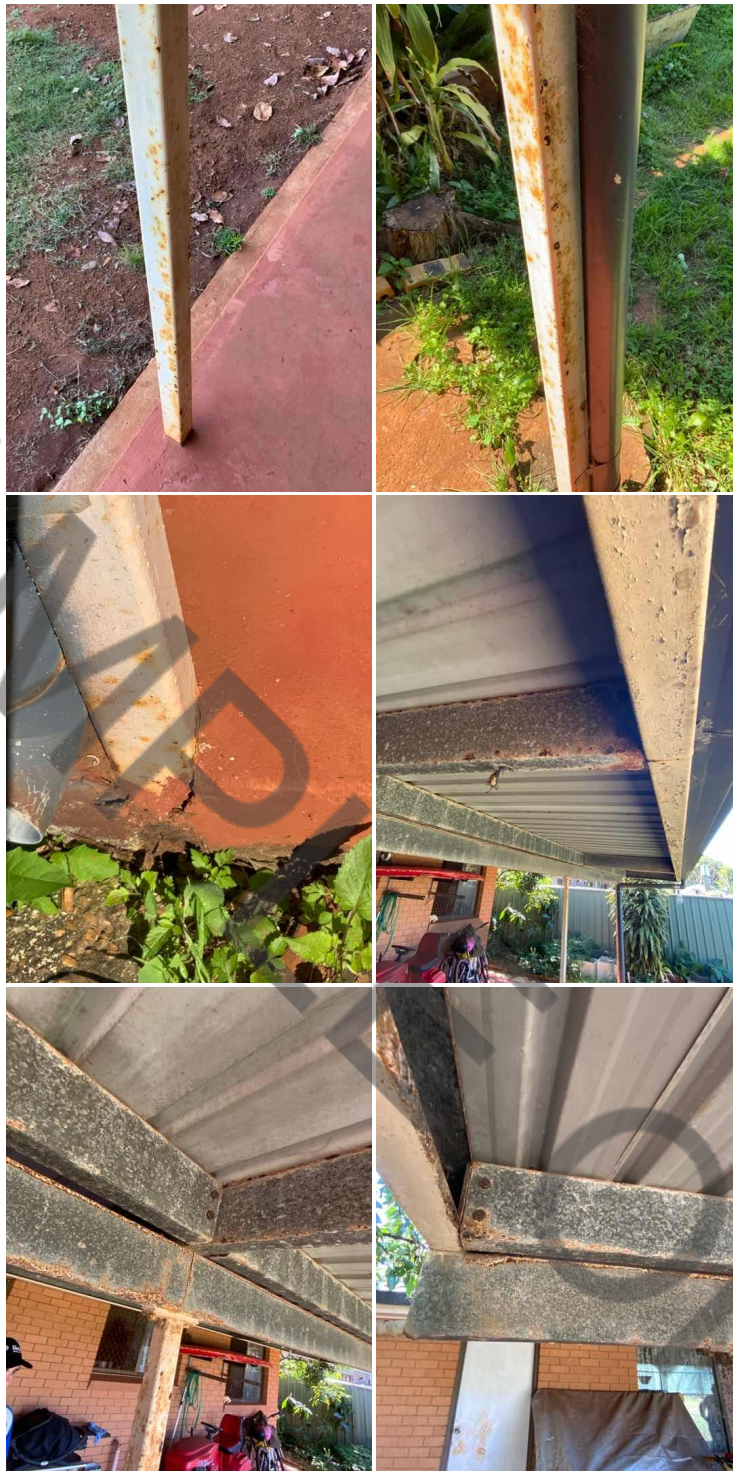
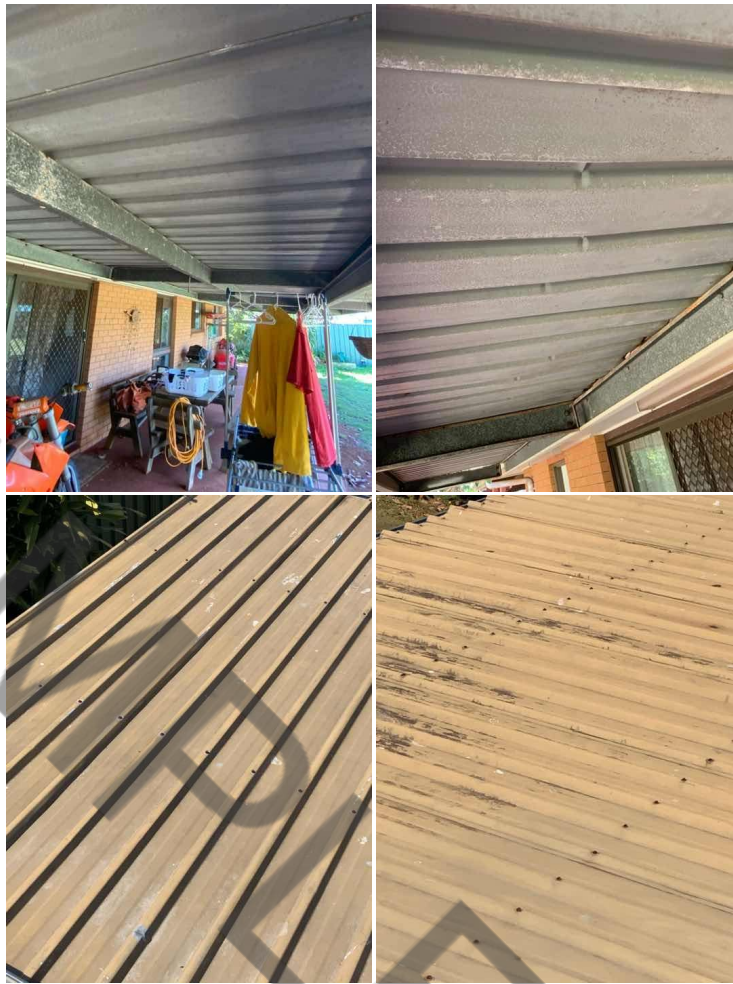
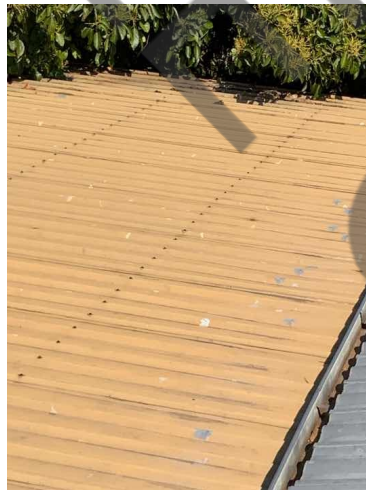
No Flashing to pergola roof
 Rust to steel
 Down pipe not connected to stormwater
 Rust roof screws
 Impact damage roof
 Further Investigation Recommended

Local Government Building Records have not been searched. Natural deterioration occurs to timbers exposed to the weather continued maintenance is required to maintain structural integrity of material. We are unable to determine if connections to Dwelling is done correctly on a visual inspection therefore, we recommend invasive inspection to determine if pergola connection to dwelling is sufficient and dwelling structure is not compromised.

Repairs recommended

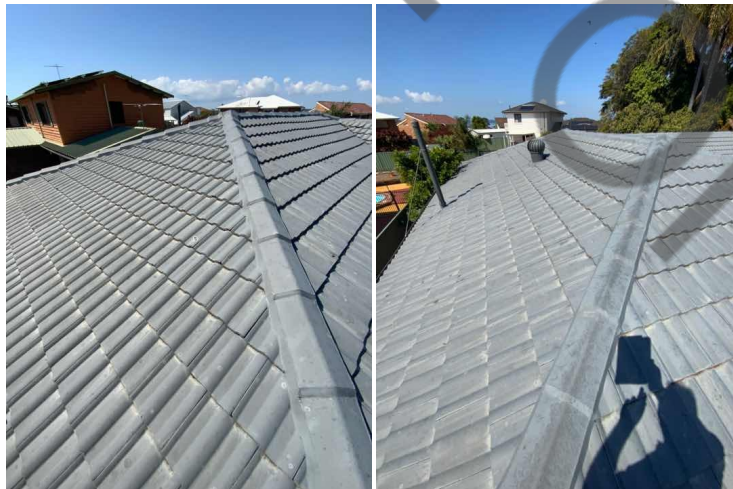
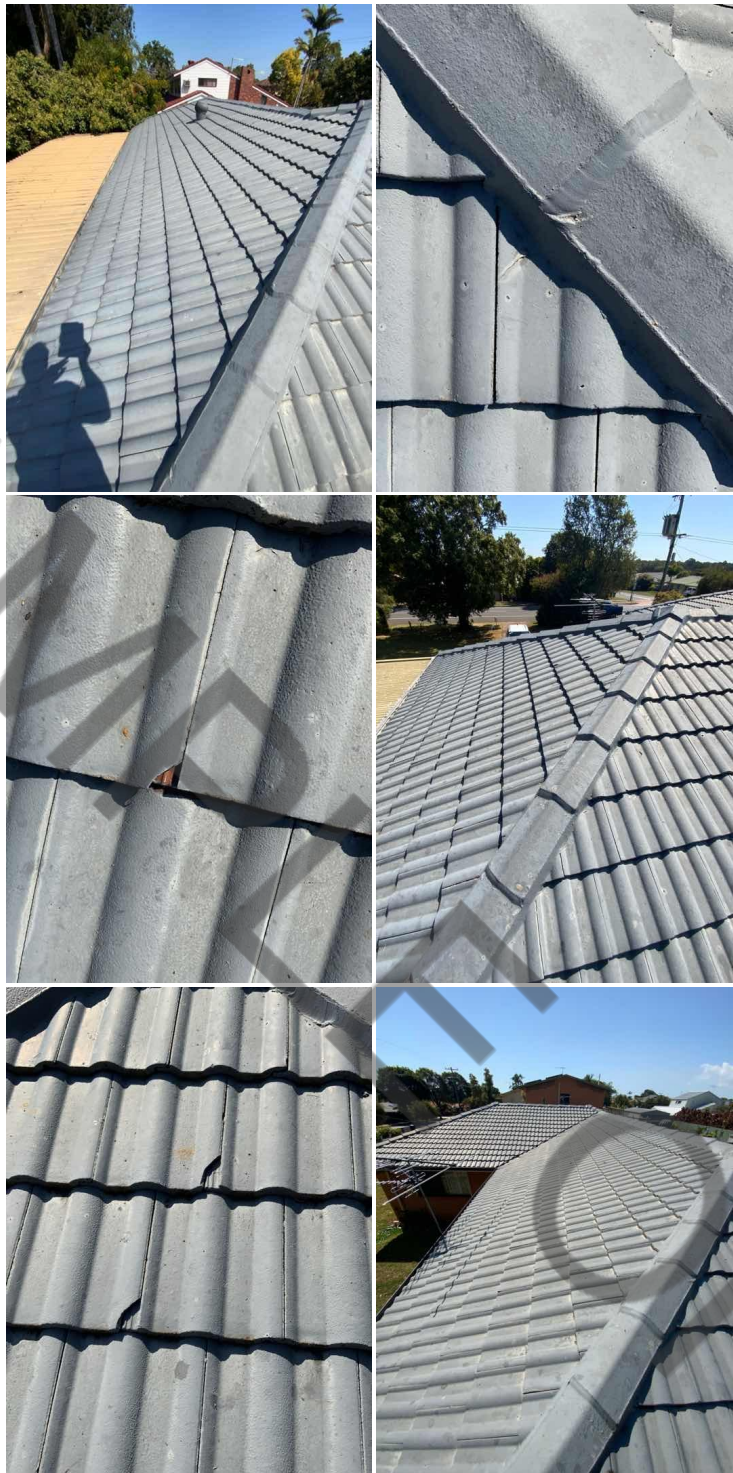
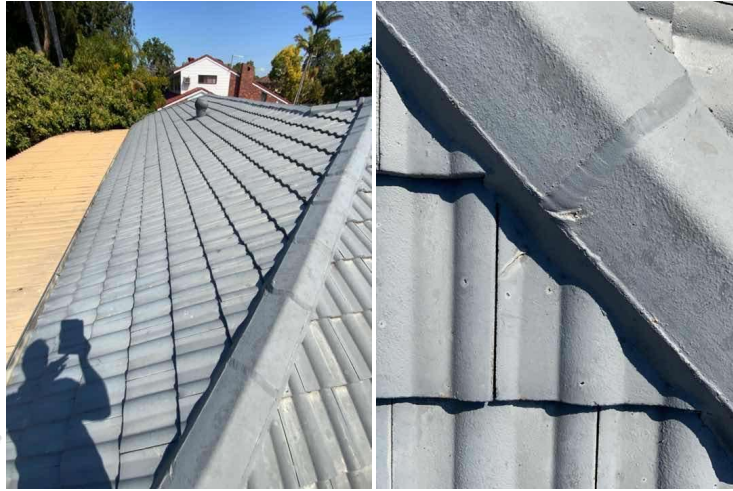
When access is not gained to exterior of roof further investigation is required to check on condition of structure before you make your purchase.

Further investigation recommended

Maintenance required

General maintenance and upkeep of roof should be done regularly to maximise life span of roofing material

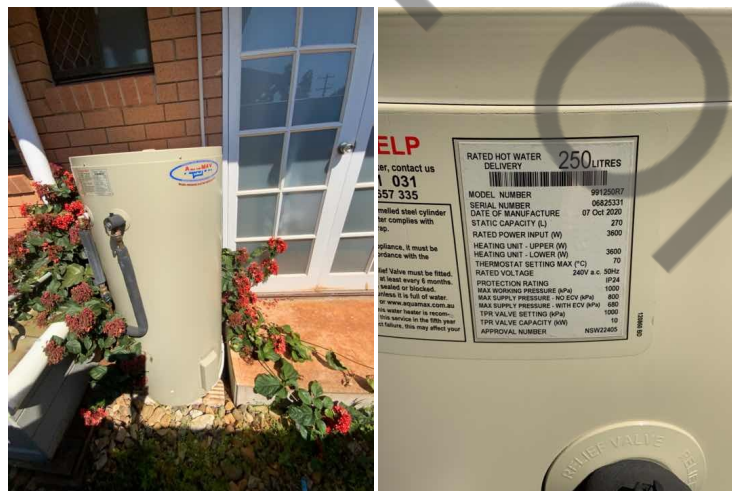
Not Tested

Hot water systems are not tested, and we recommend you engage a plumber and electrician to test system before your purchase.

Consult Plumber for further advice

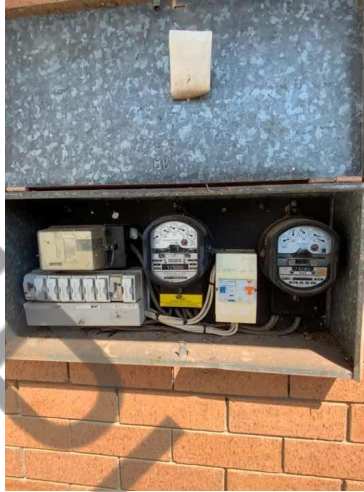
Earth leakage circuit breaker (Safety Switch) should be tested by a licensed electrician to determine if all power and lighting outlets are connected to this circuit and that it works. Meter box and switch boards require electrician to test and inspect, this is recommended before you purchase the property.

Yes - Consult an Electrician

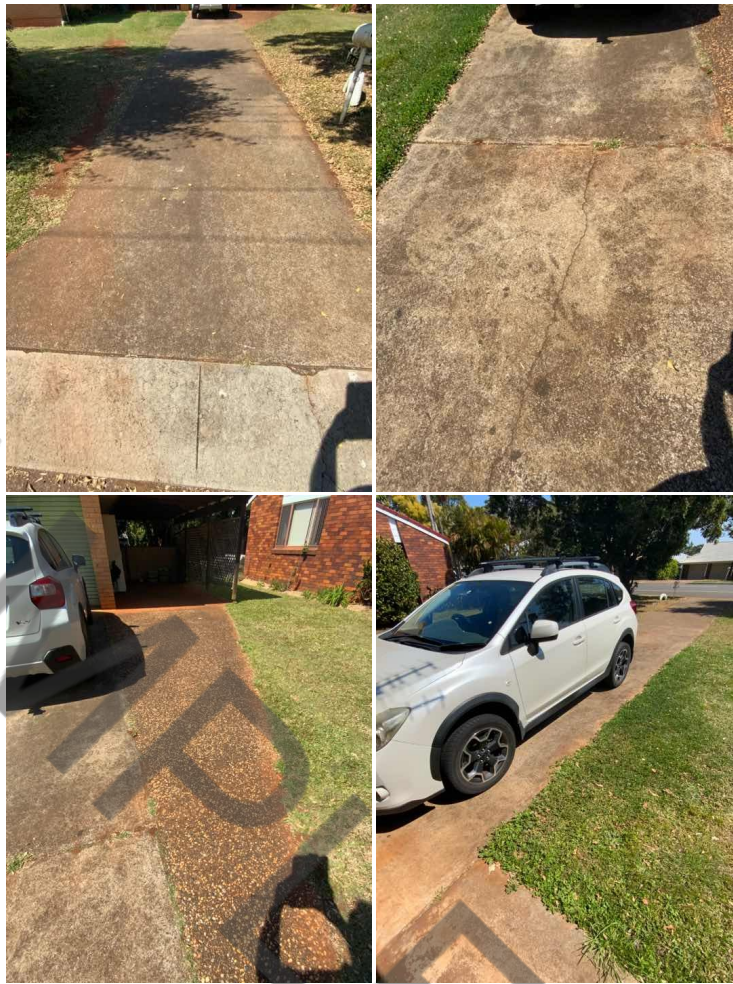
Classification-Slight <5mm

Cars parked on driveway restricted inspection

When cracking has occurred to the driveway, these cracks are caused by product shrinkage during curing and/or settlement. We are unable to determine the expected consequences on a visual inspection therefore you should consult a structural engineer to determine future consequences.

You can not quantify degree of movement through visual inspection, further investigation is required.

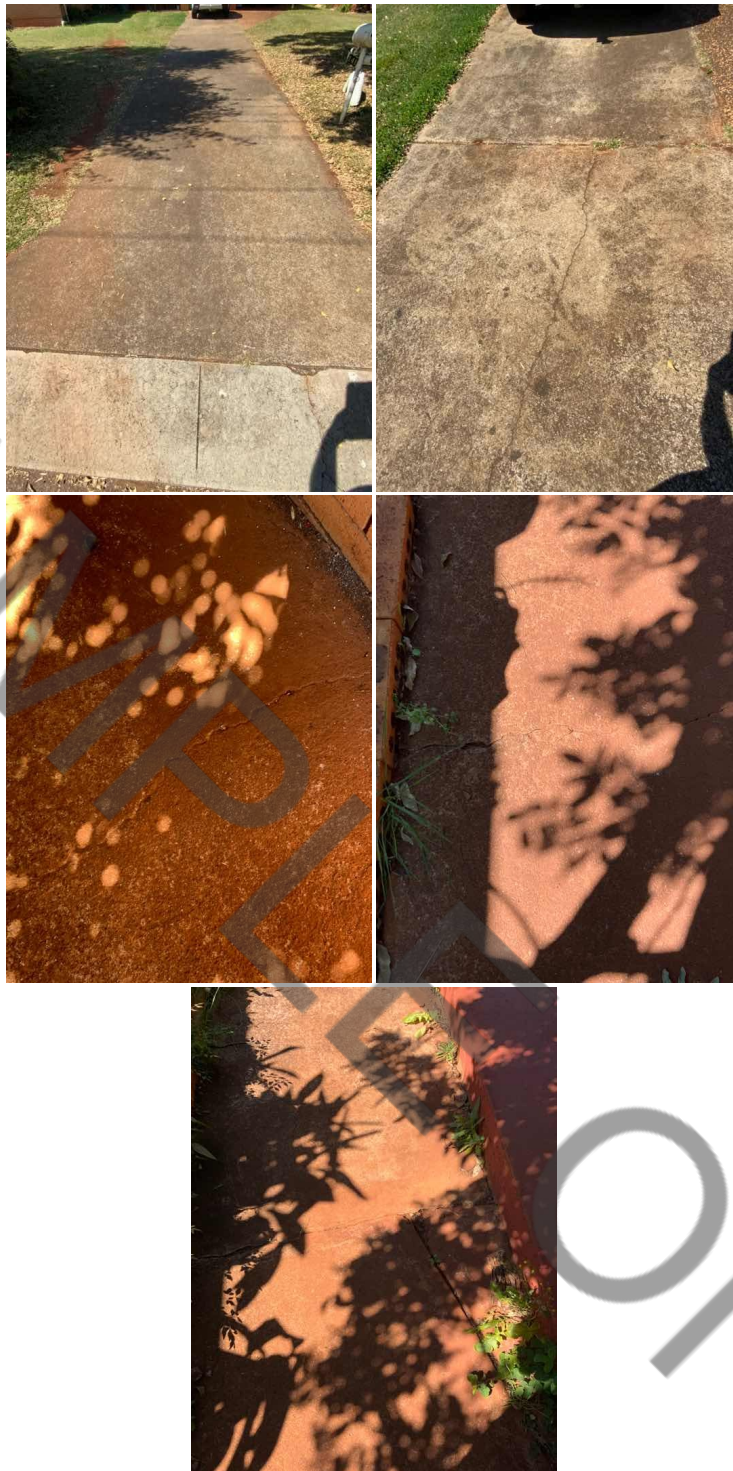
Cracking to path

Classification-Slight <5mm

When cracking has occurred to the Pathways, these cracks are caused by product shrinkage during curing and/or settlement. We are unable to determine the expected consequences on a visual inspection therefore you should consult a structural engineer to determine future consequences.

You cannot quantify degree of movement through visual inspection, further investigation is required.

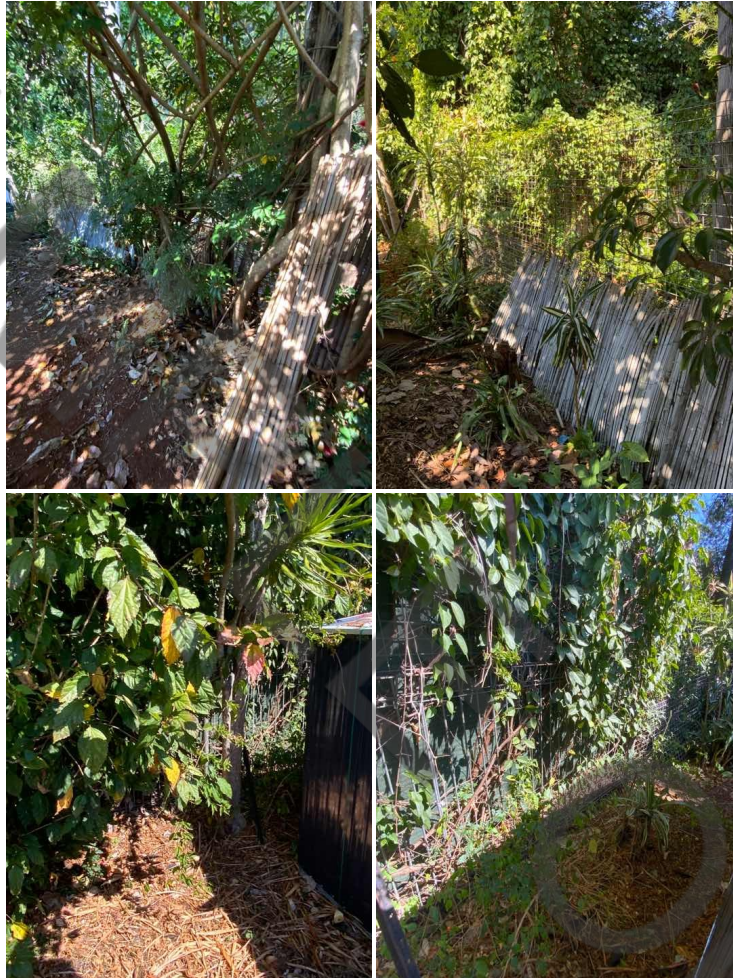
Restricted access due to vegetation

Further investigation recommended

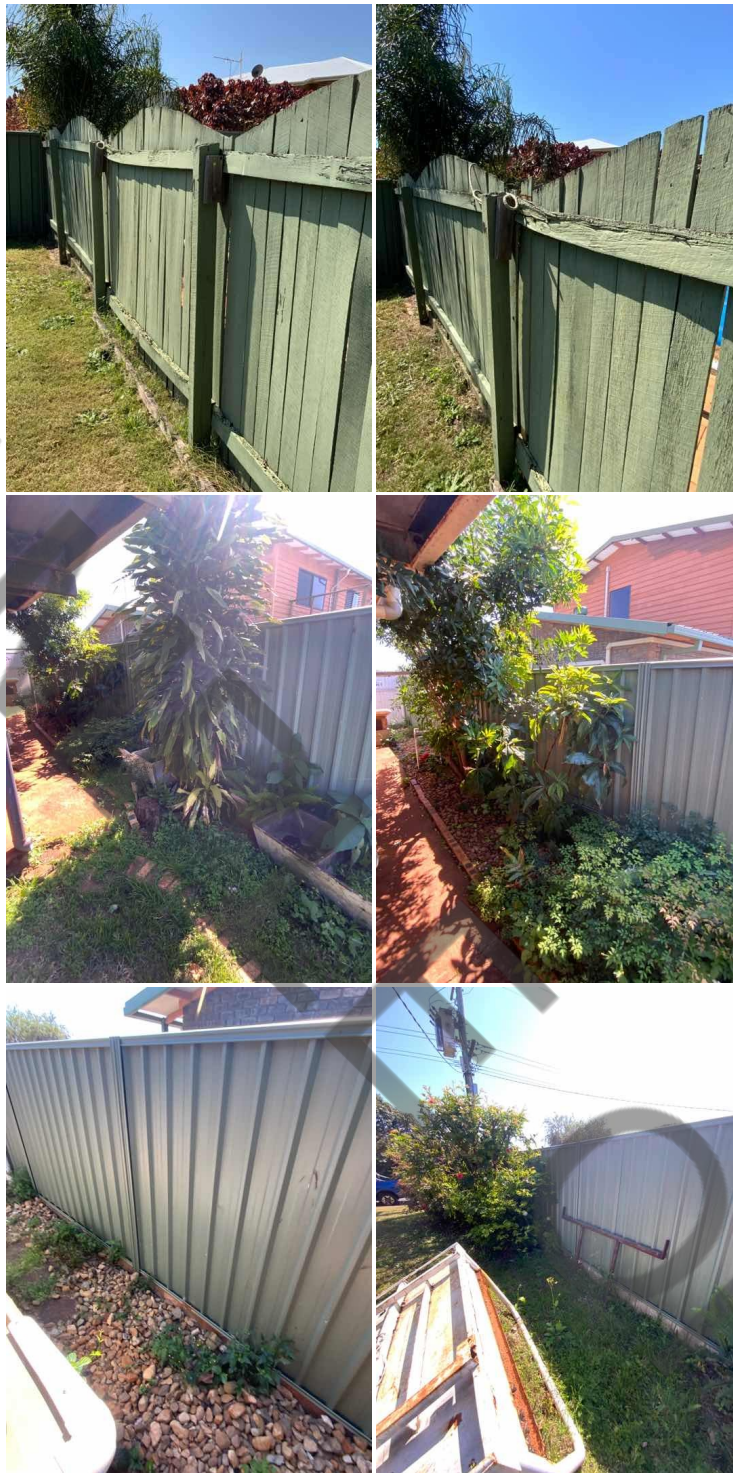
Restricted access due to vegetation

When cracking has occurred to the Fencing, these cracks are caused by product shrinkage during curing and/or settlement. We are unable to determine the expected consequences on a visual inspection therefore you should consult a structural engineer to determine future consequences.

You can not quantify degree of movement through visual inspection, further investigation is required.

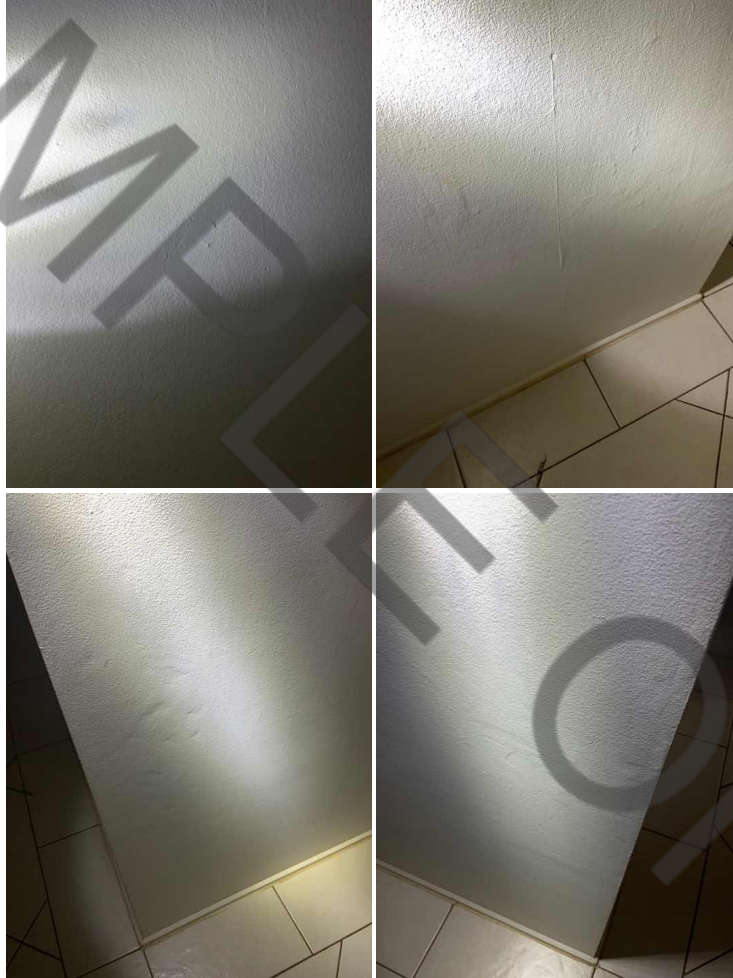
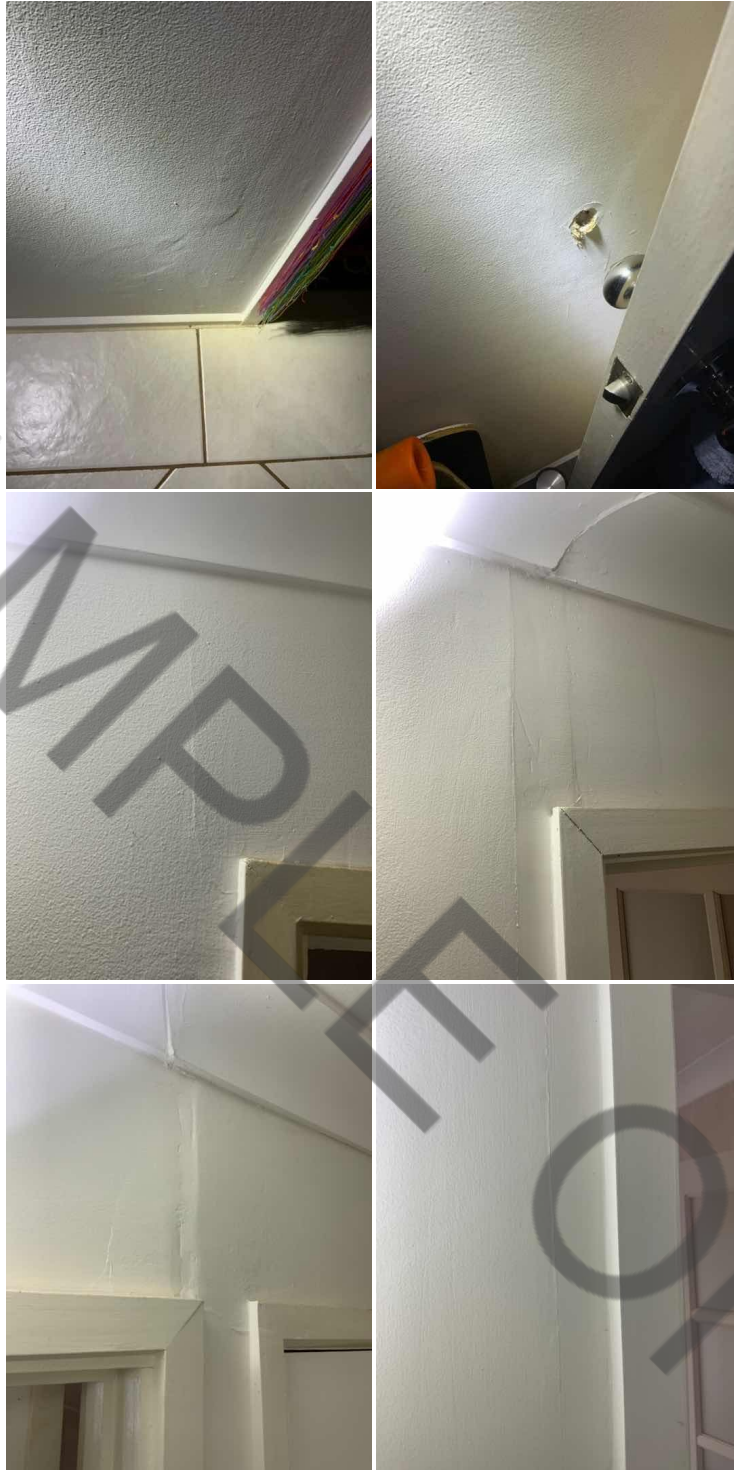
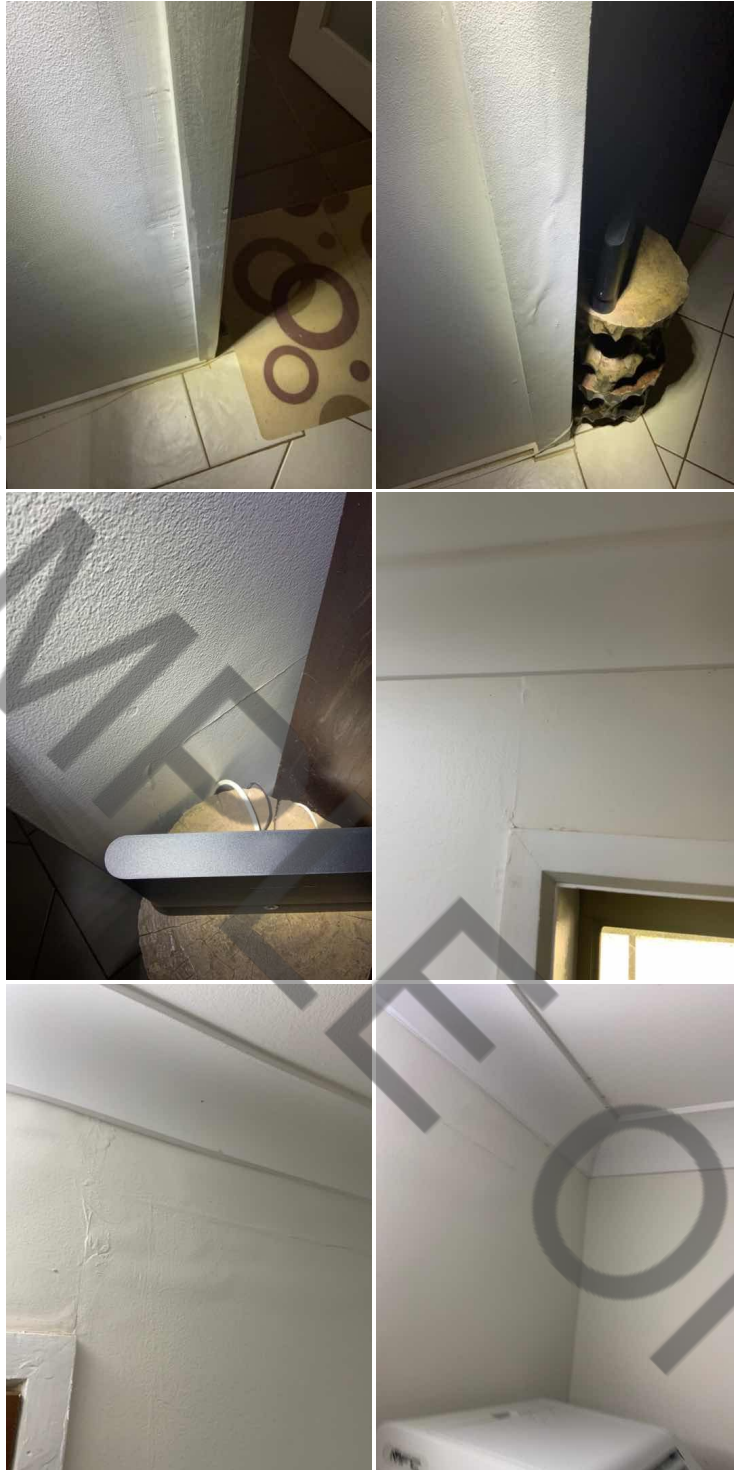
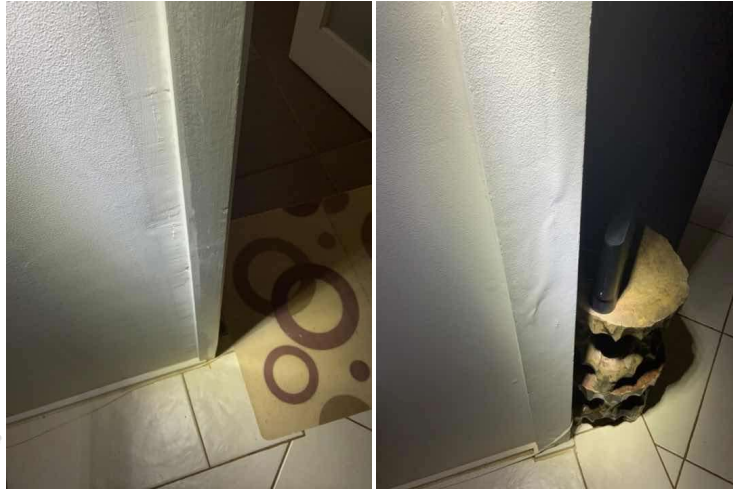
F C sheeting prior to 1990 may contain asbestos therefore an asbestos audit is recommended. Any repairs or maintenance of asbestos products should only be undertaken by professionals trained in handling of asbestos. Asbestos products should be kept painted and sealed to eliminate air borne fibres

When cracks are noted, an evaluation is required to determine the causes or potential causes of the cracking. You can not quantify degree of movement through visual inspection; further investigation is required.

Further investigation recommended

Maintenance required

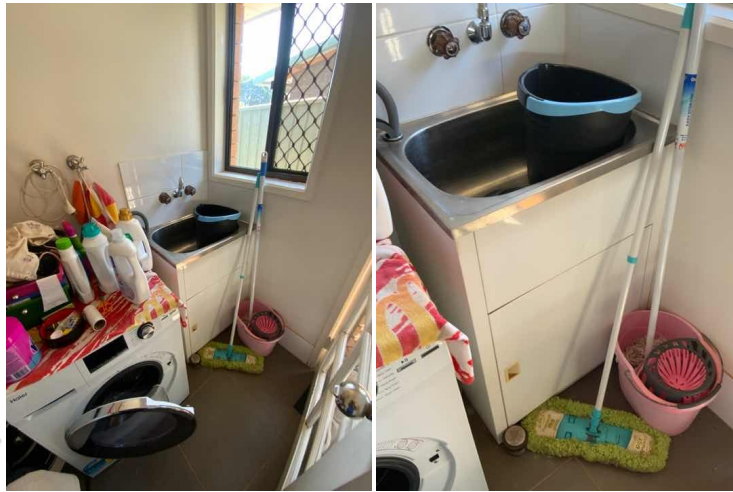
Laundry tub in good to fair condition

Defects noted in the inspection, you should consult a builder for costing before you make your purchase.

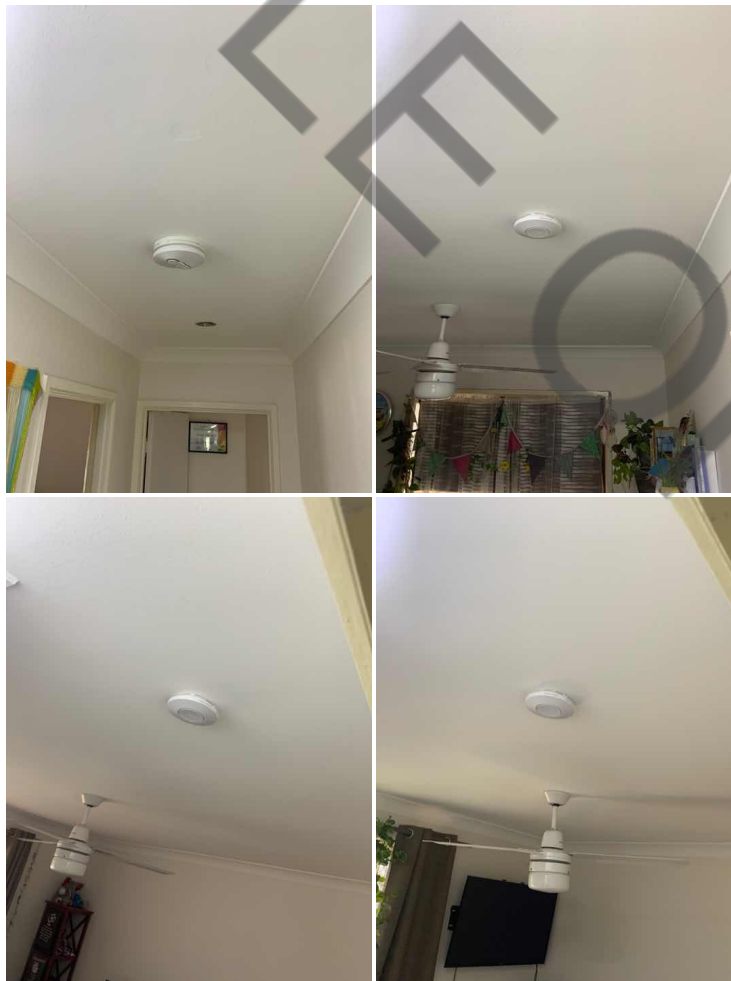
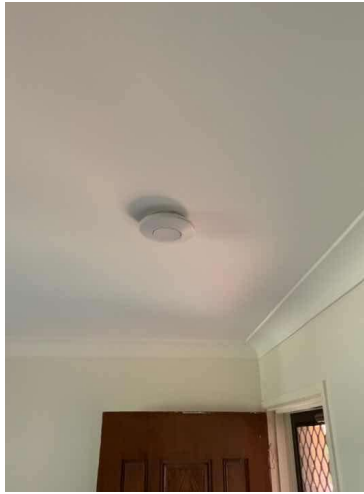
Entry ceiling
Hallway Ceiling
Bedroom ceiling

Consult electrician for further advice
Not Tested
